# **FIRE SAFETY**

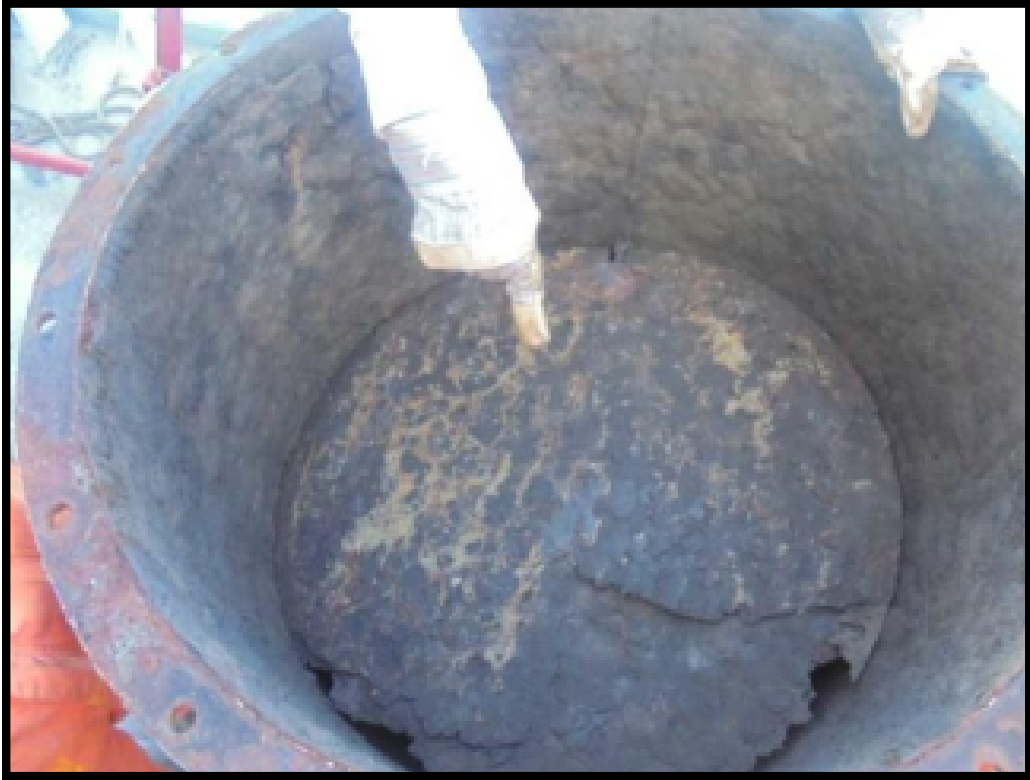
**Corrosion of fire damper**

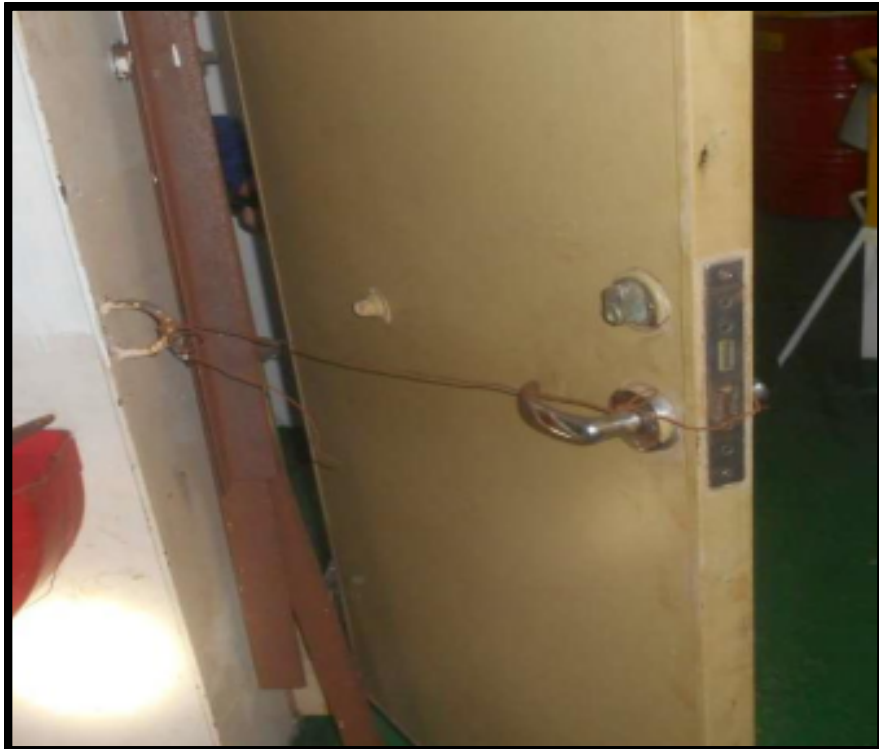
**Hold-back wire attached to fire door**

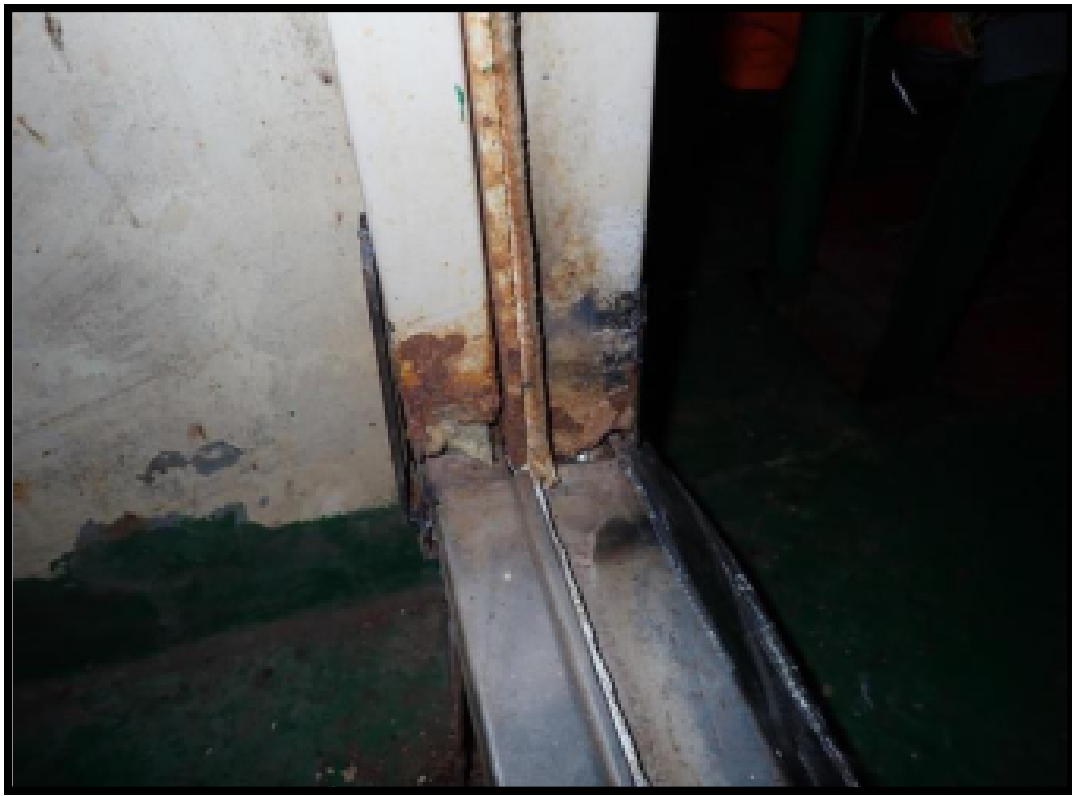
**Corrosion of fire door and door frame**

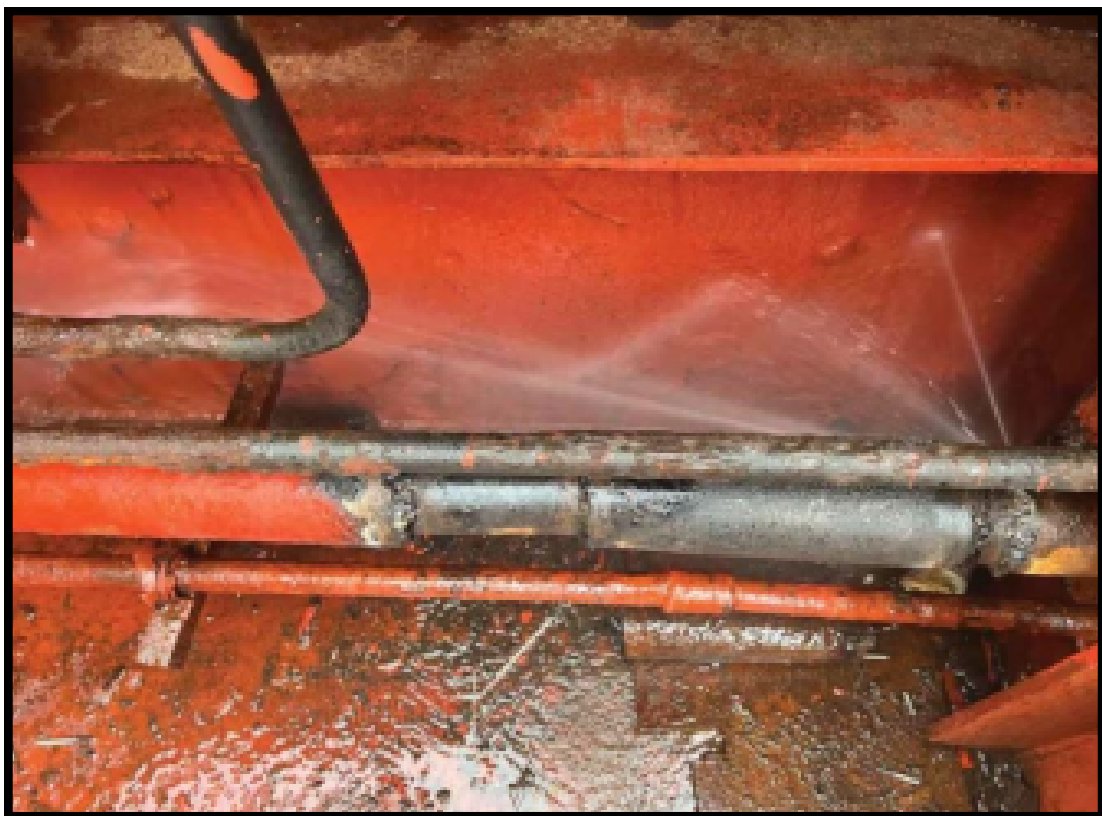
**Leakage of fire line**

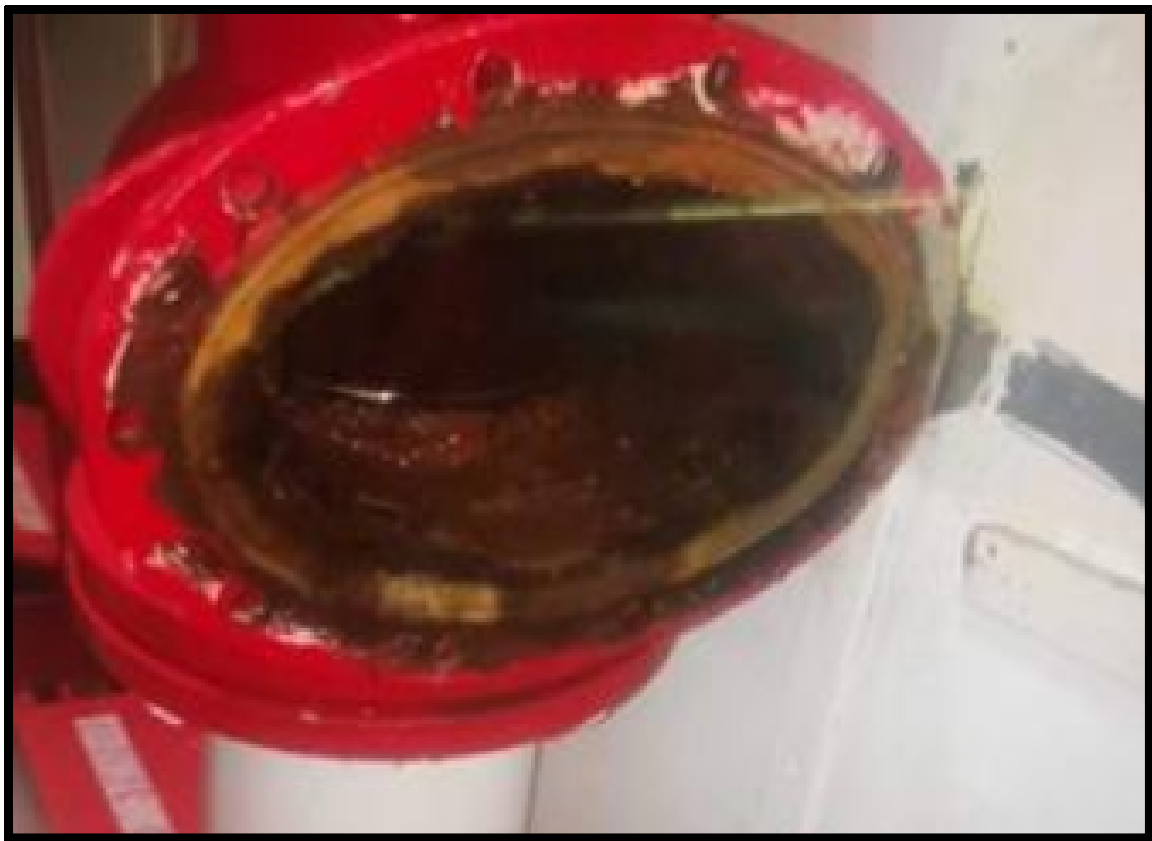
**Malfunction of fire line  
isolation valve due to mud**

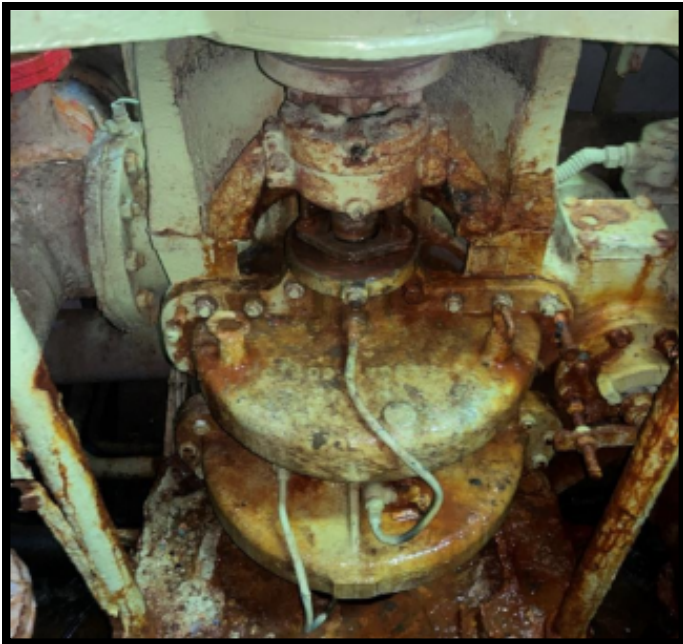
**Corrosion and  
leakage of  
main fire pump**

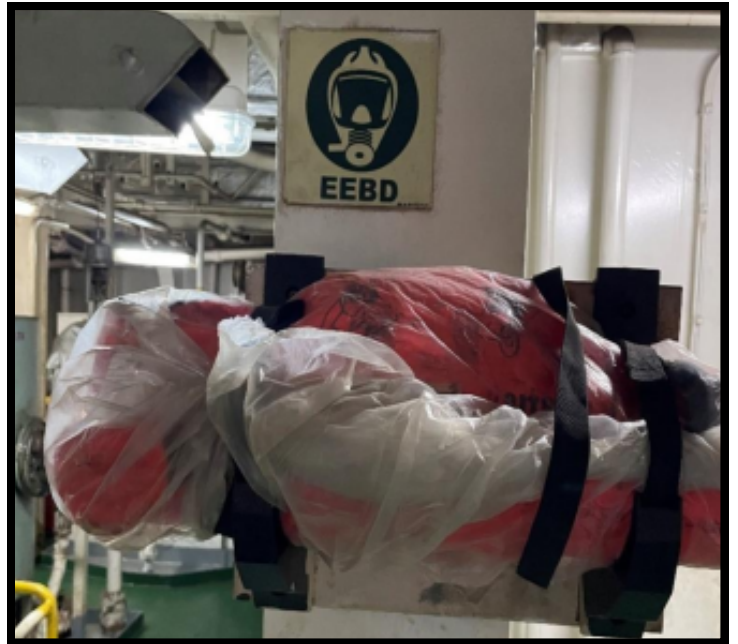
**EEBD covered by  
flammable  
material (vinyl)**

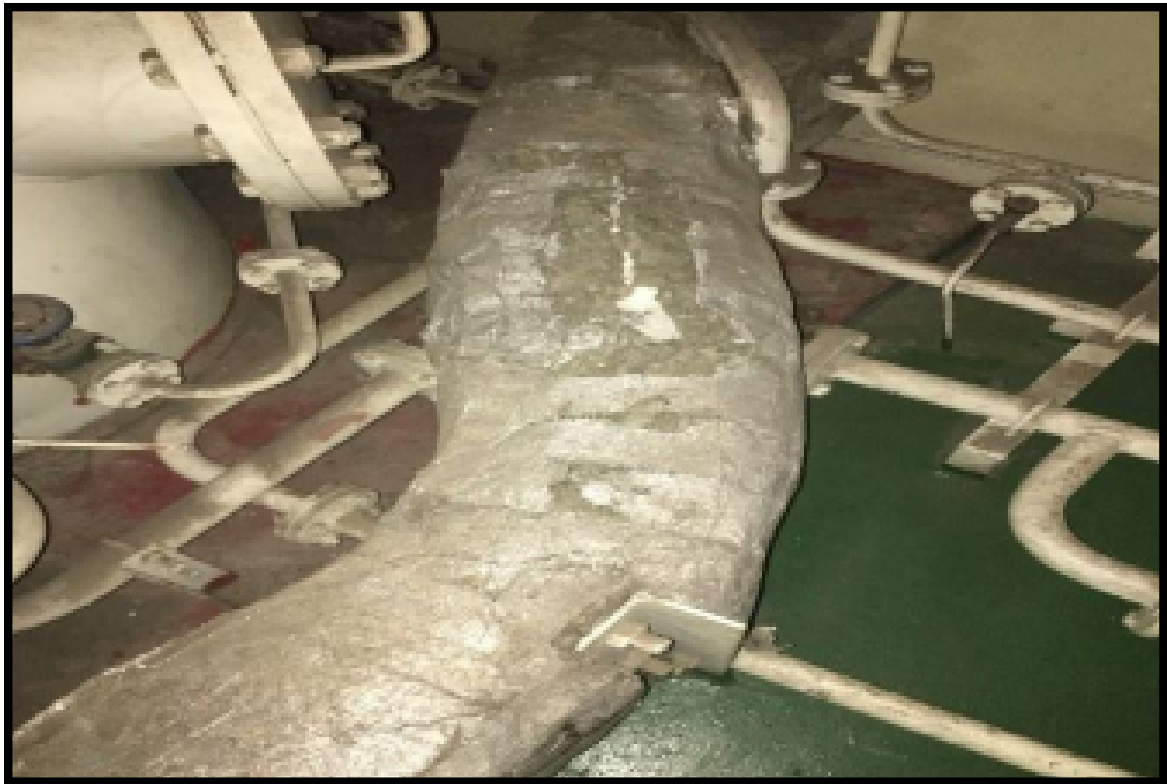
**Damage to insulation material for fire line suction pipe (passing through engine room)**

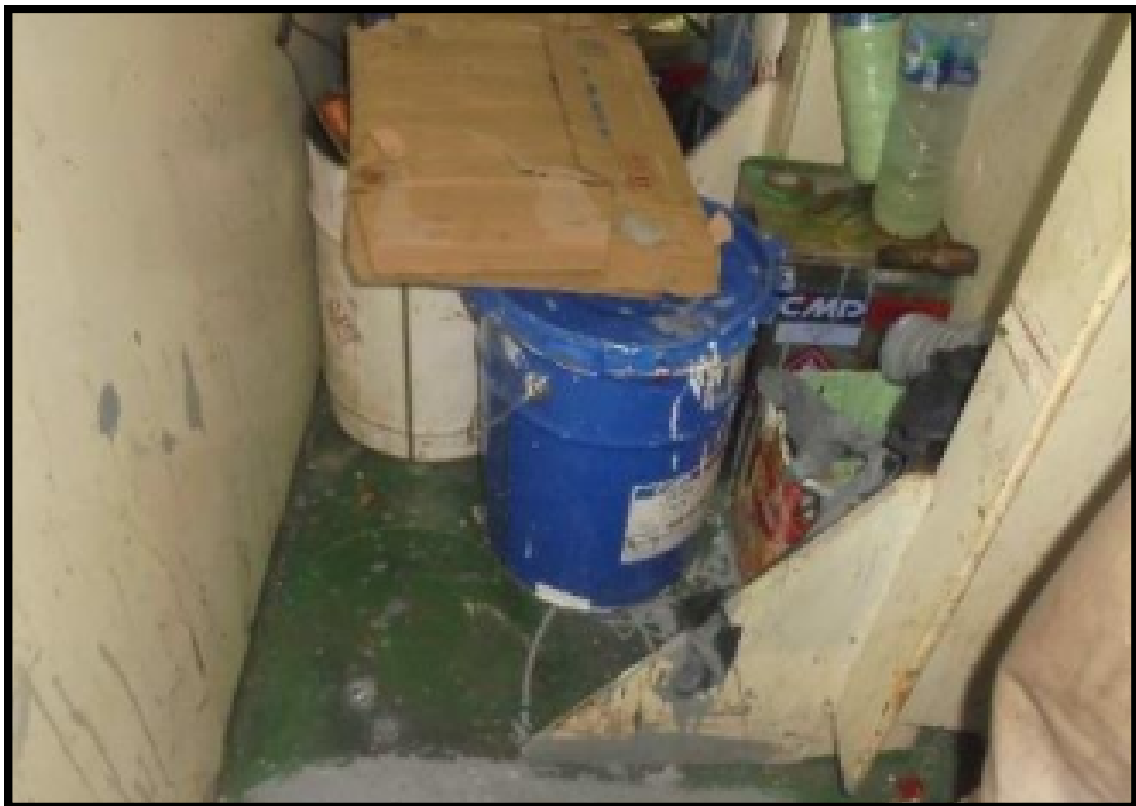
**Improper stowage of flammable material in accommodation**

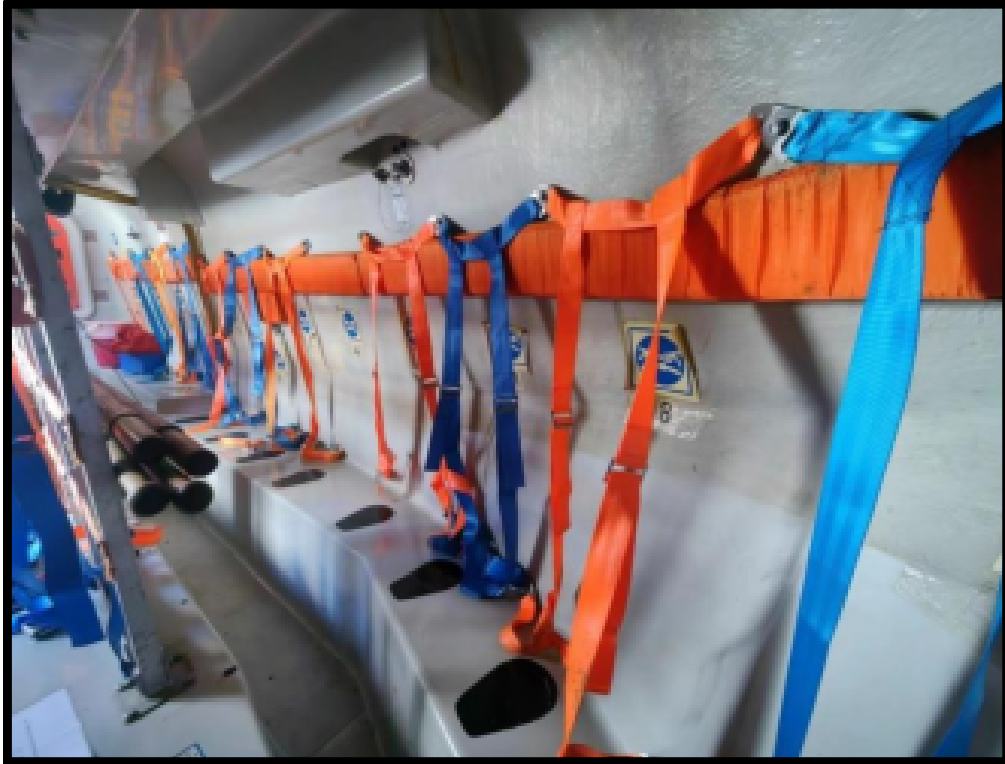
**Lifeboat safety belt partly missing**

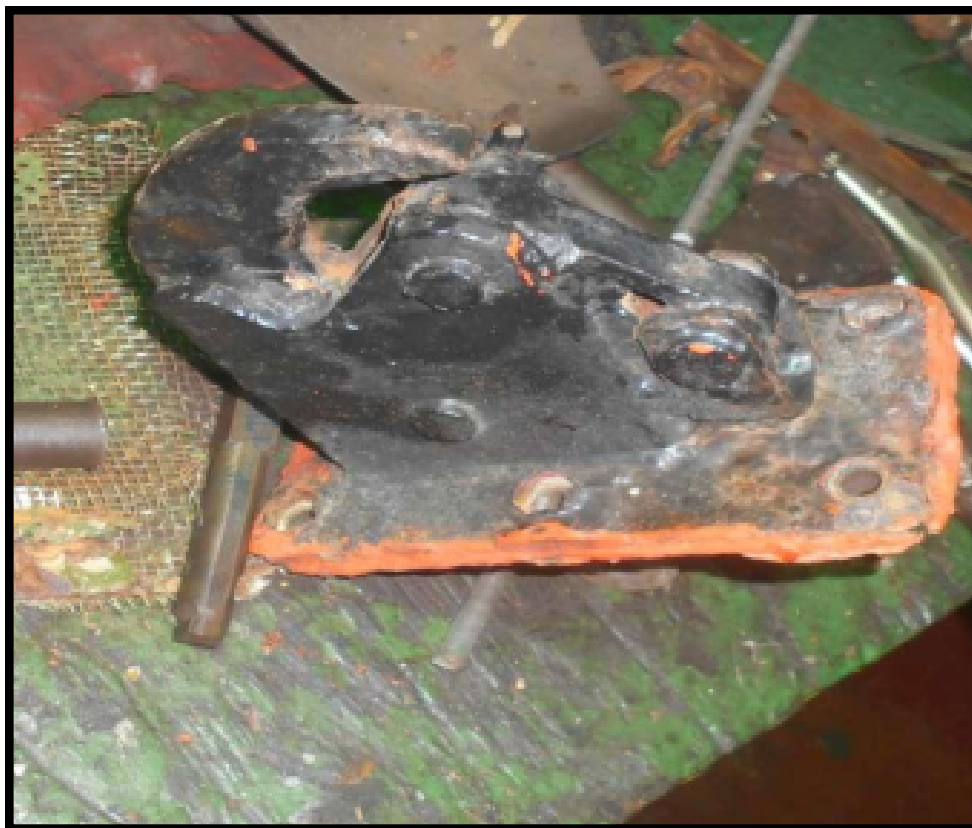
**Inoperative lifeboat hook**

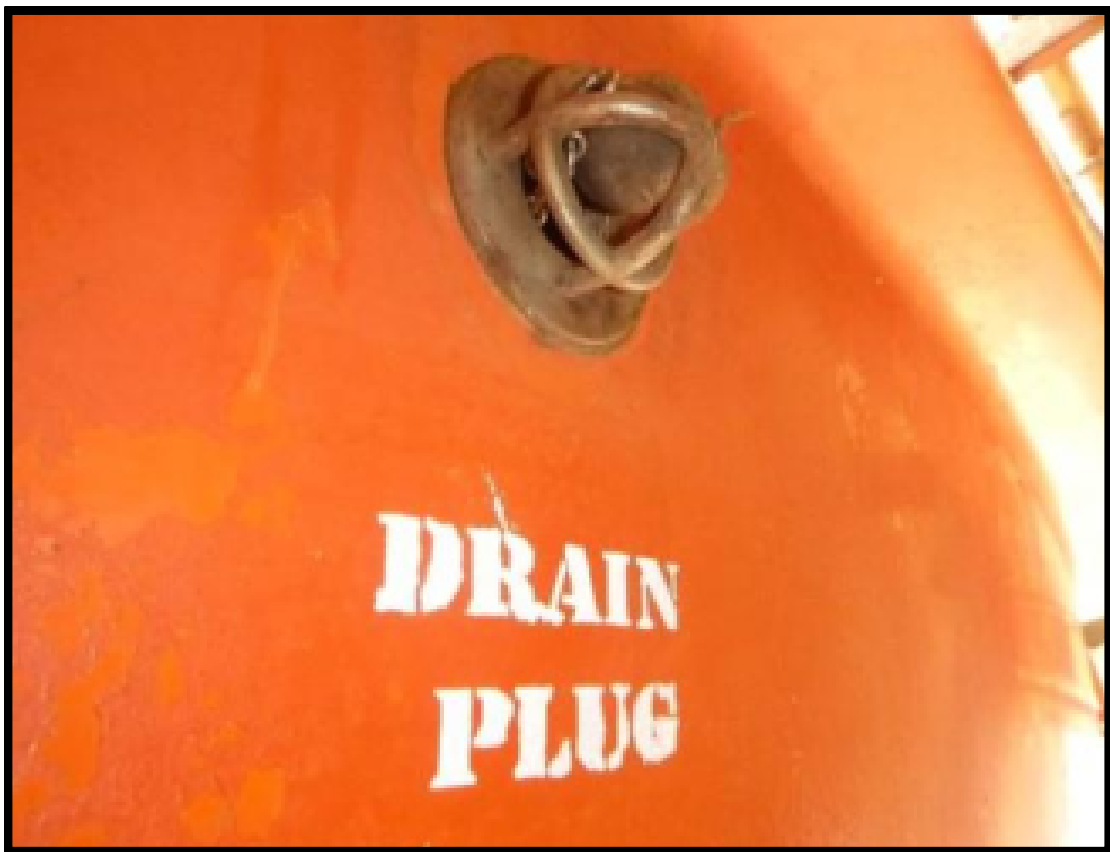
**Deterioration of lifeboat drain plug  
(rubber ball)**

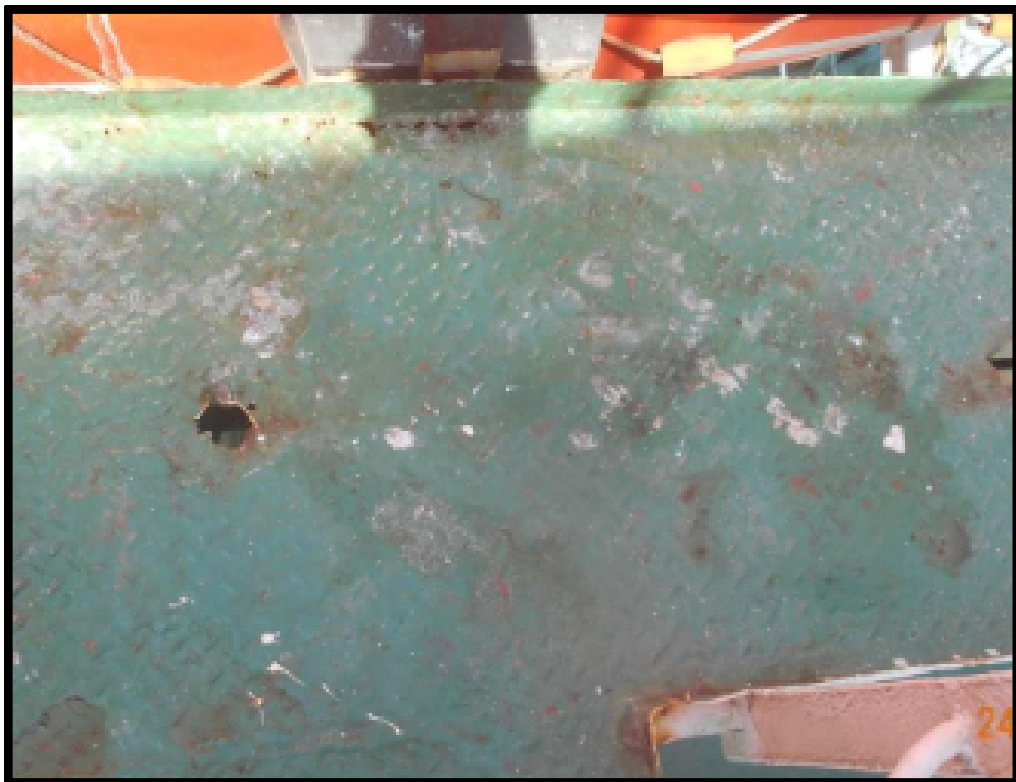
**Holes on lifeboat embarkation  
station platform**

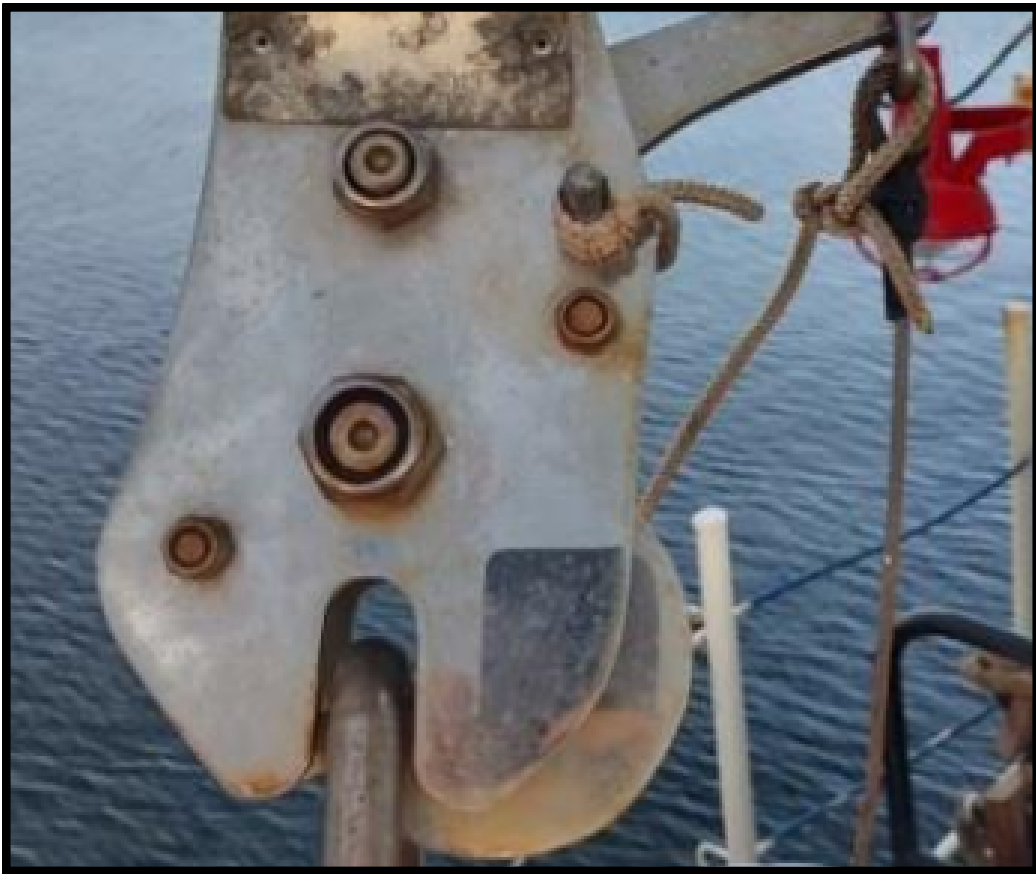
**Usage of unapproved life raft hook**

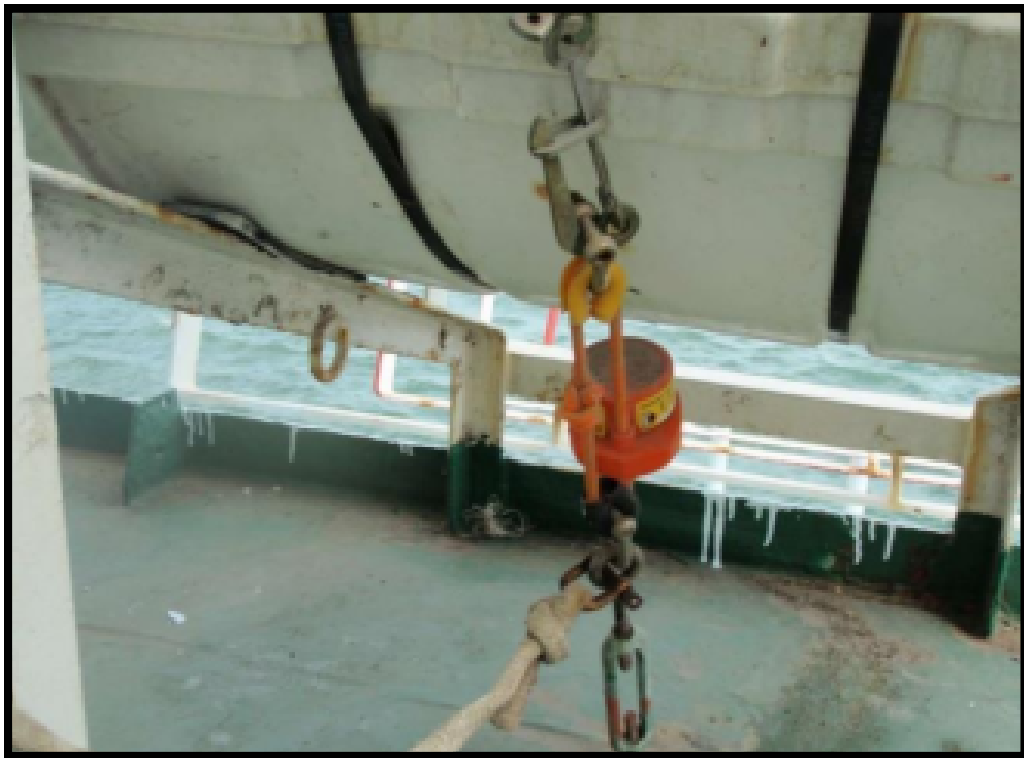
**Improper connection of  
hydrostatic release unit (HRU)**

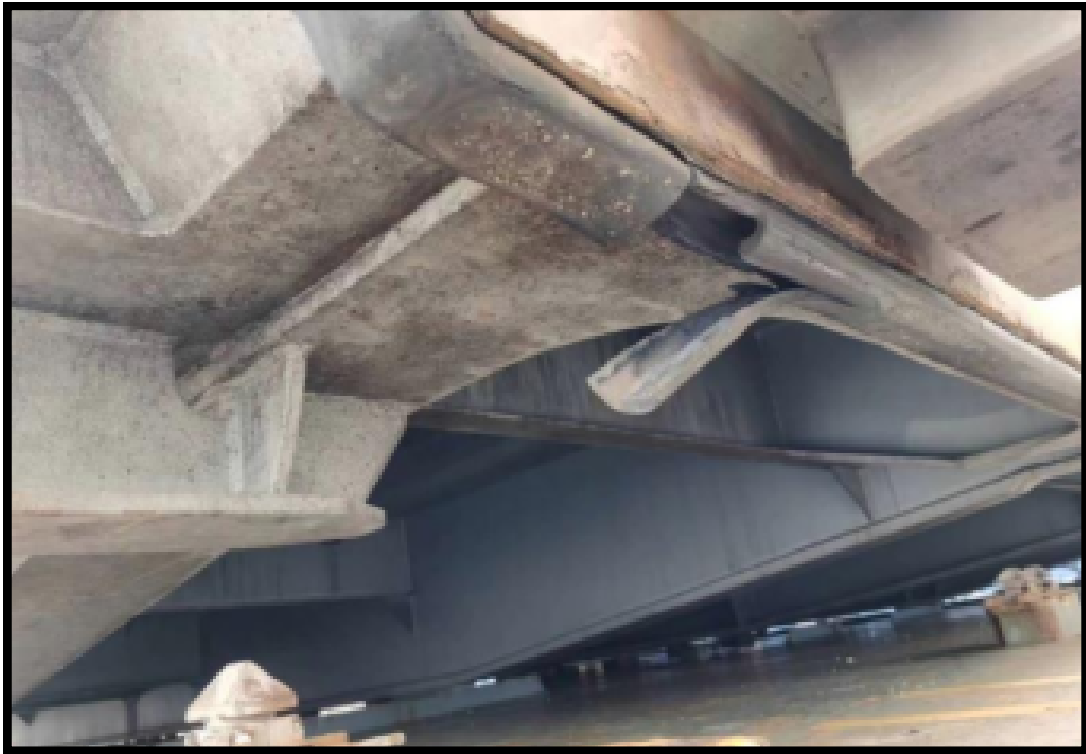
**Hatch cover packing partly missing**

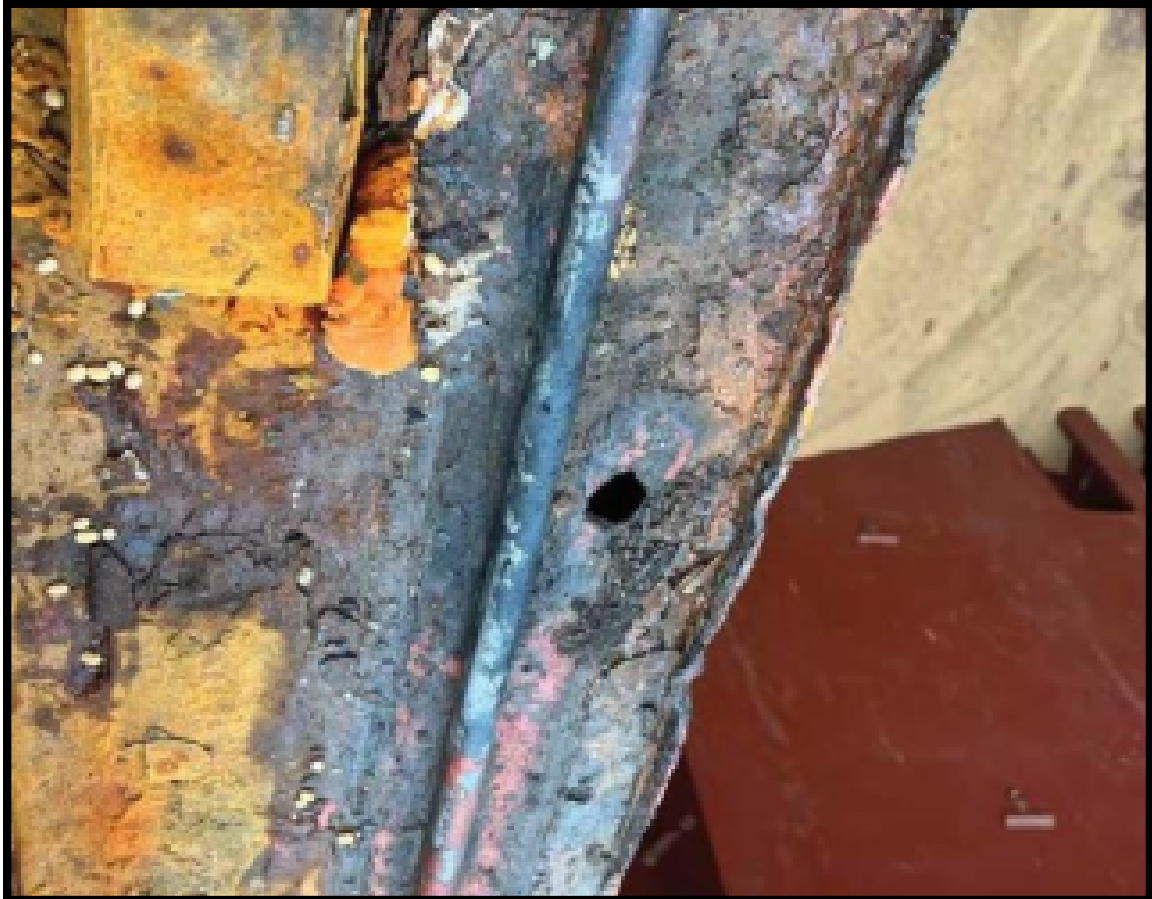
**Corrosion of hatch coaming**

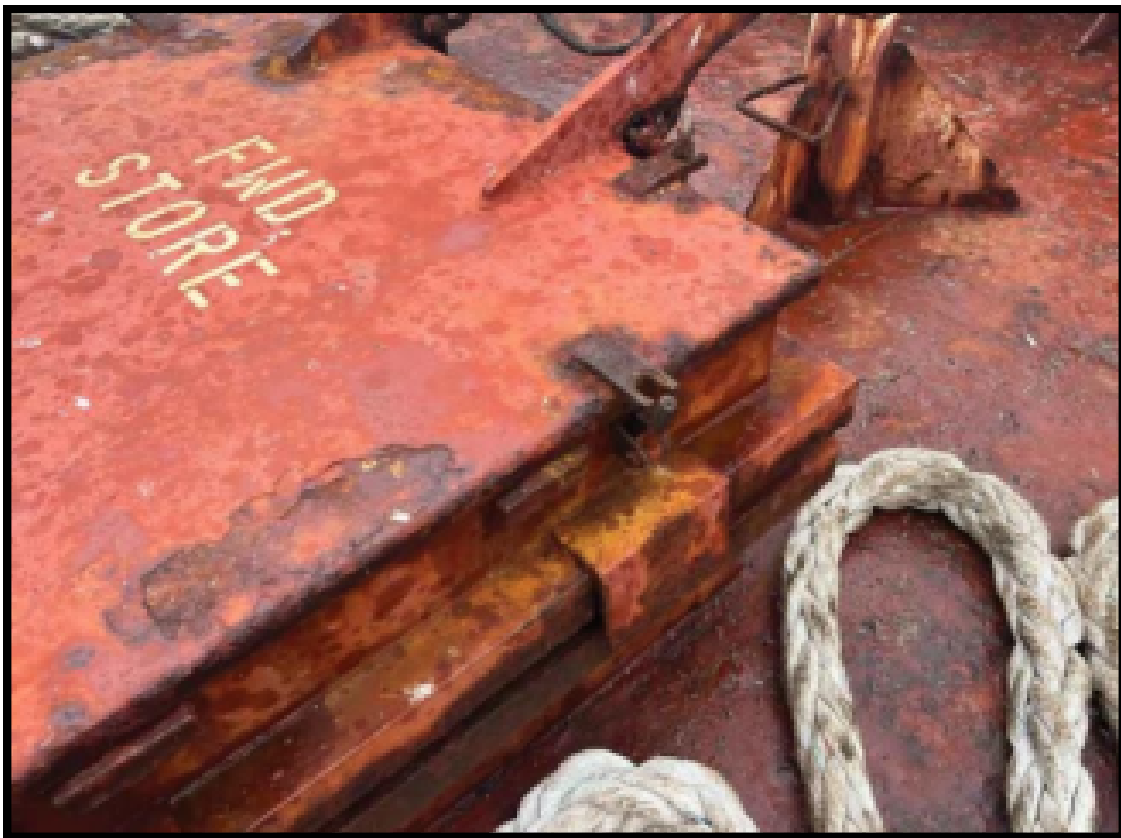
**Access hatch closing bolt partly missing**

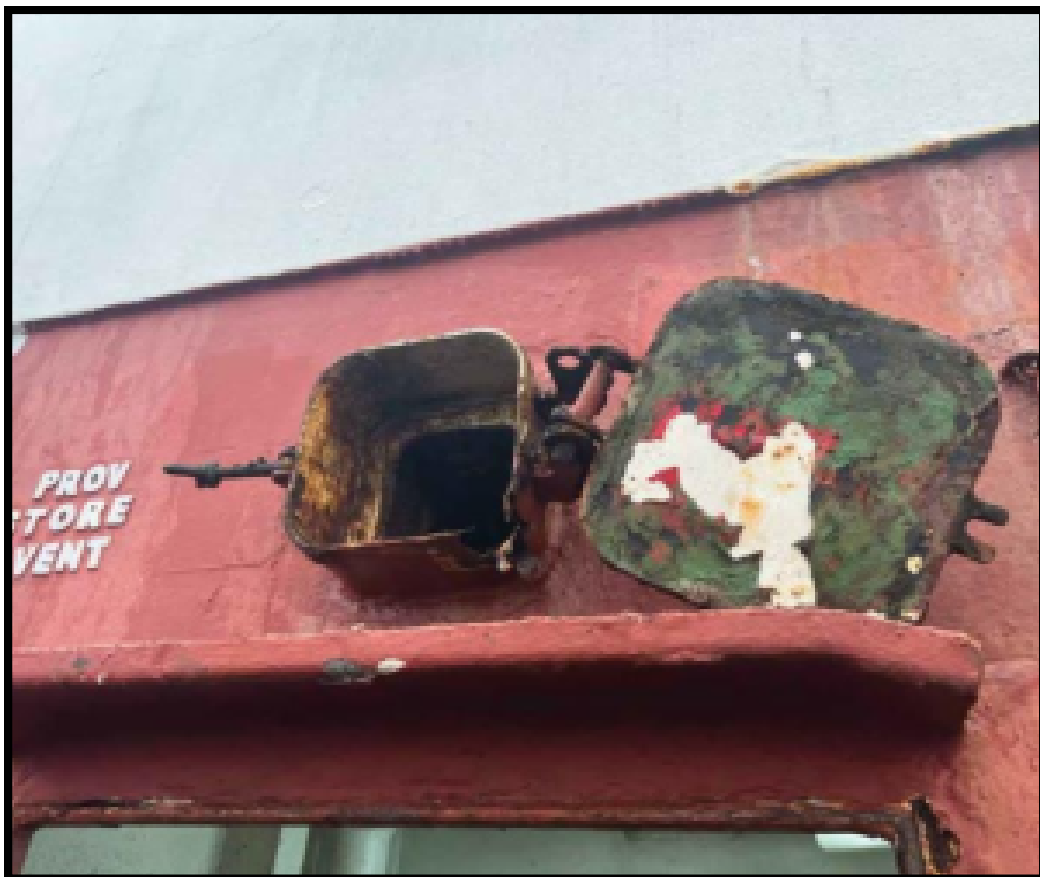
**Corrosion of natural ventilator**

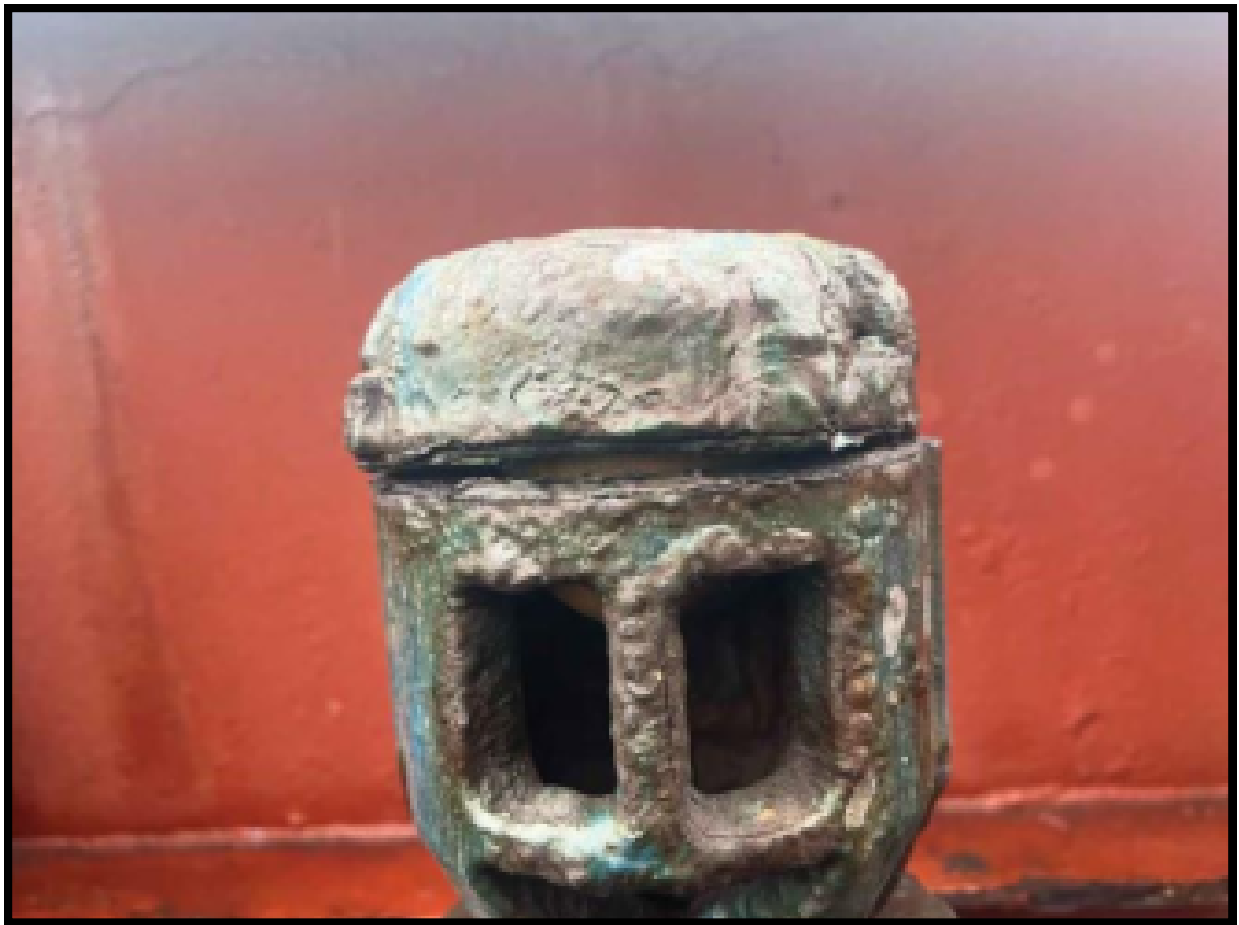
**Corrosion of air pipe head**

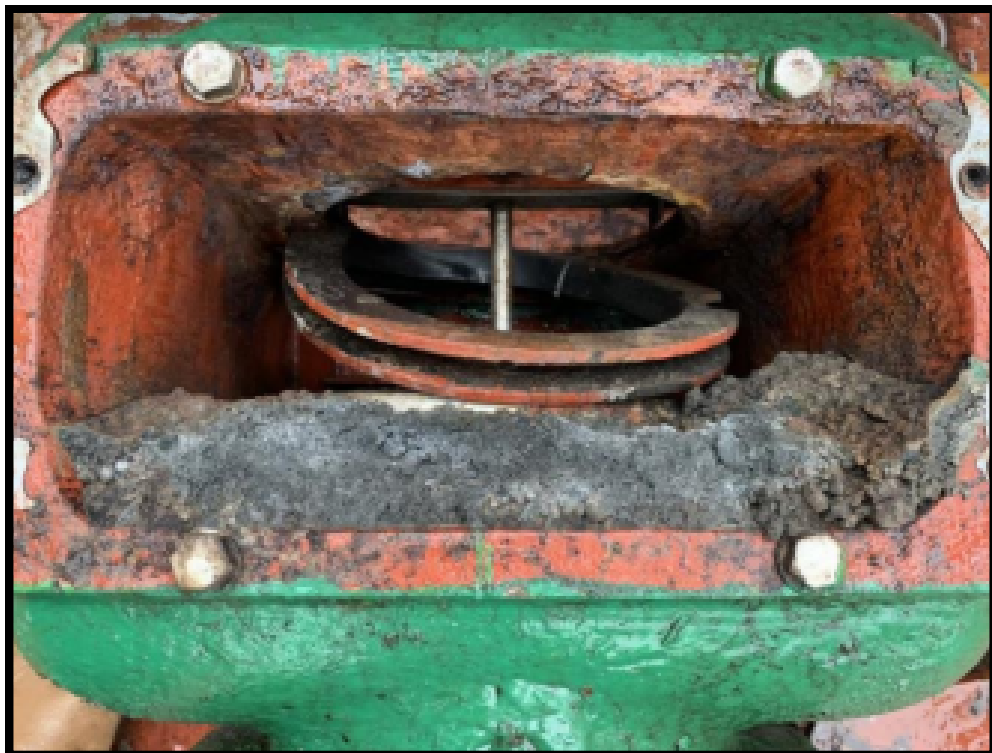
**Defective air pipe head fittings**

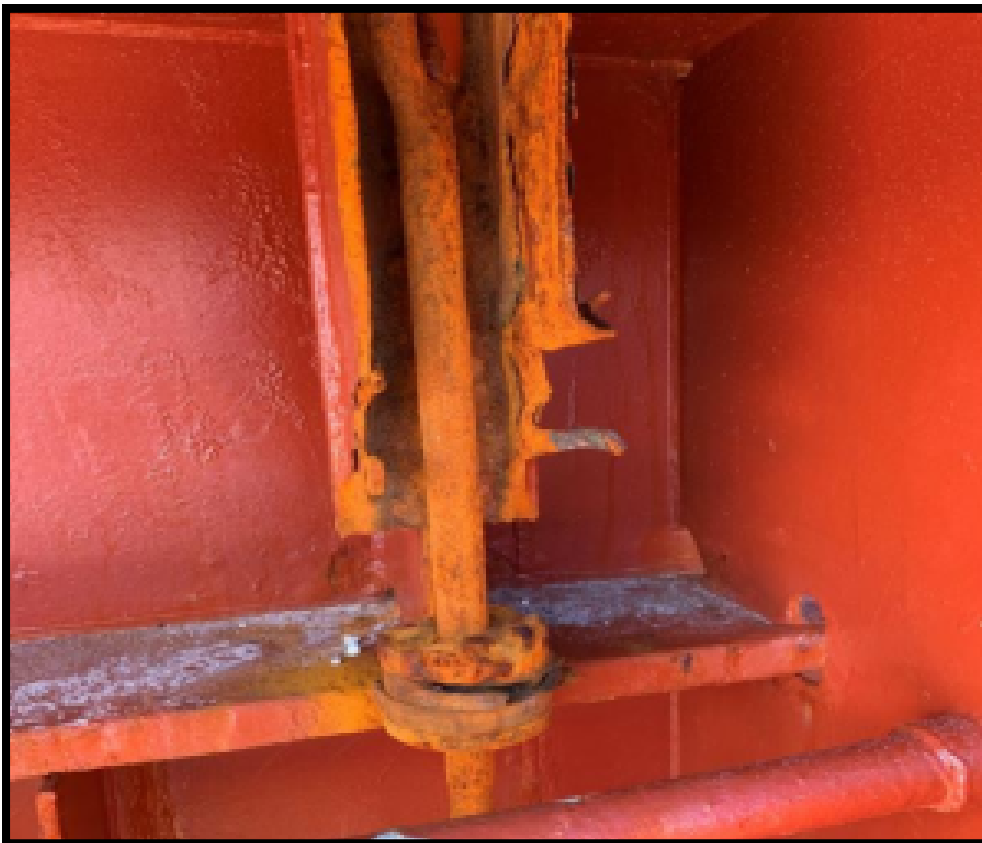
**Corrosion of hatch cover cleat**

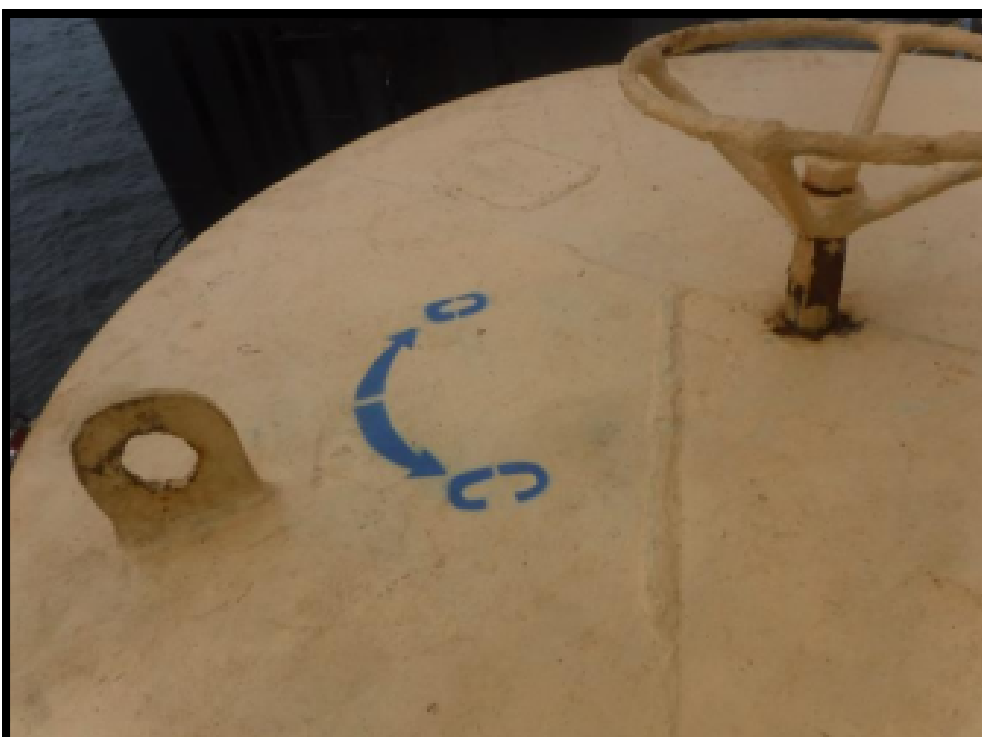
**Incorrect marking of  
ventilation open/close direction**

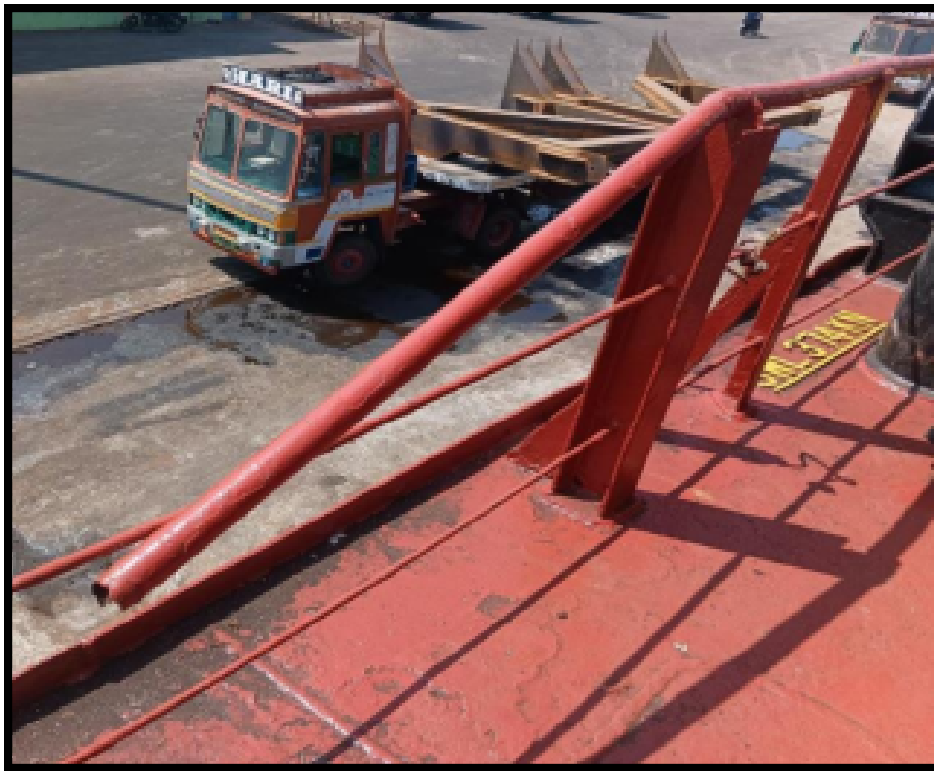
**Damage to upper deck handrail**

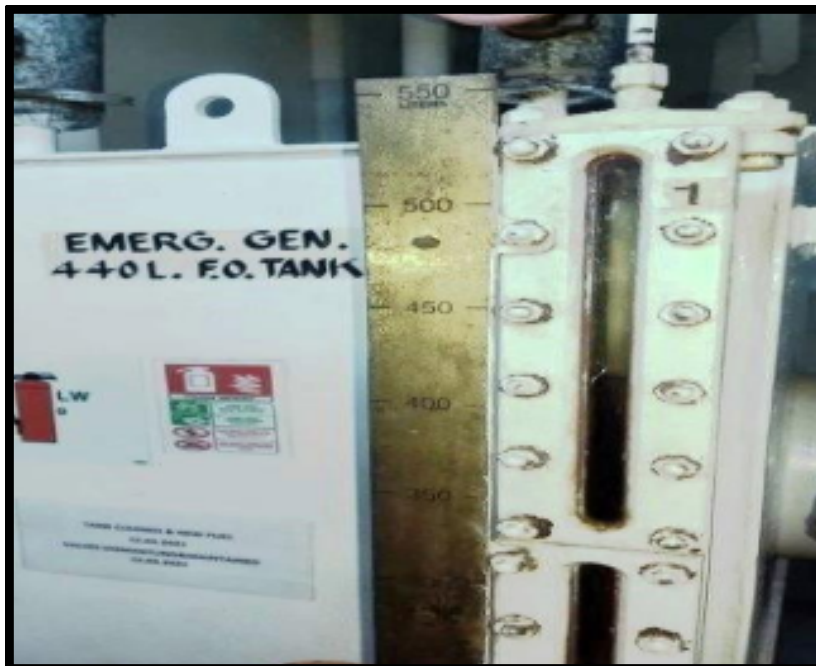
**Insufficient diesel for  
emergency generator**

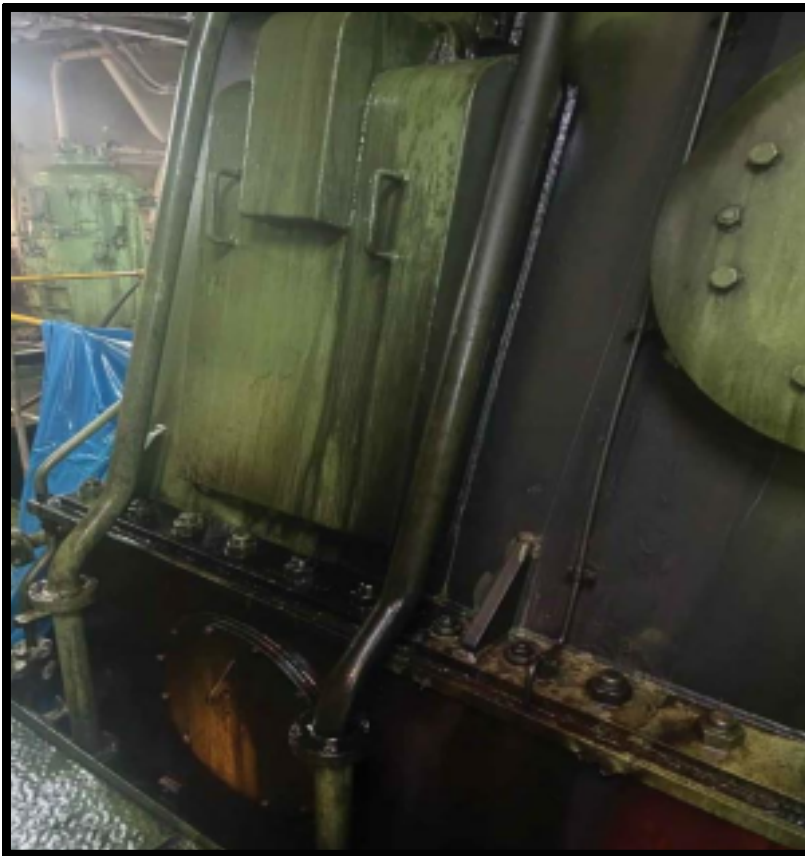
**Leakage and  
accumulation  
of main  
engine oil**

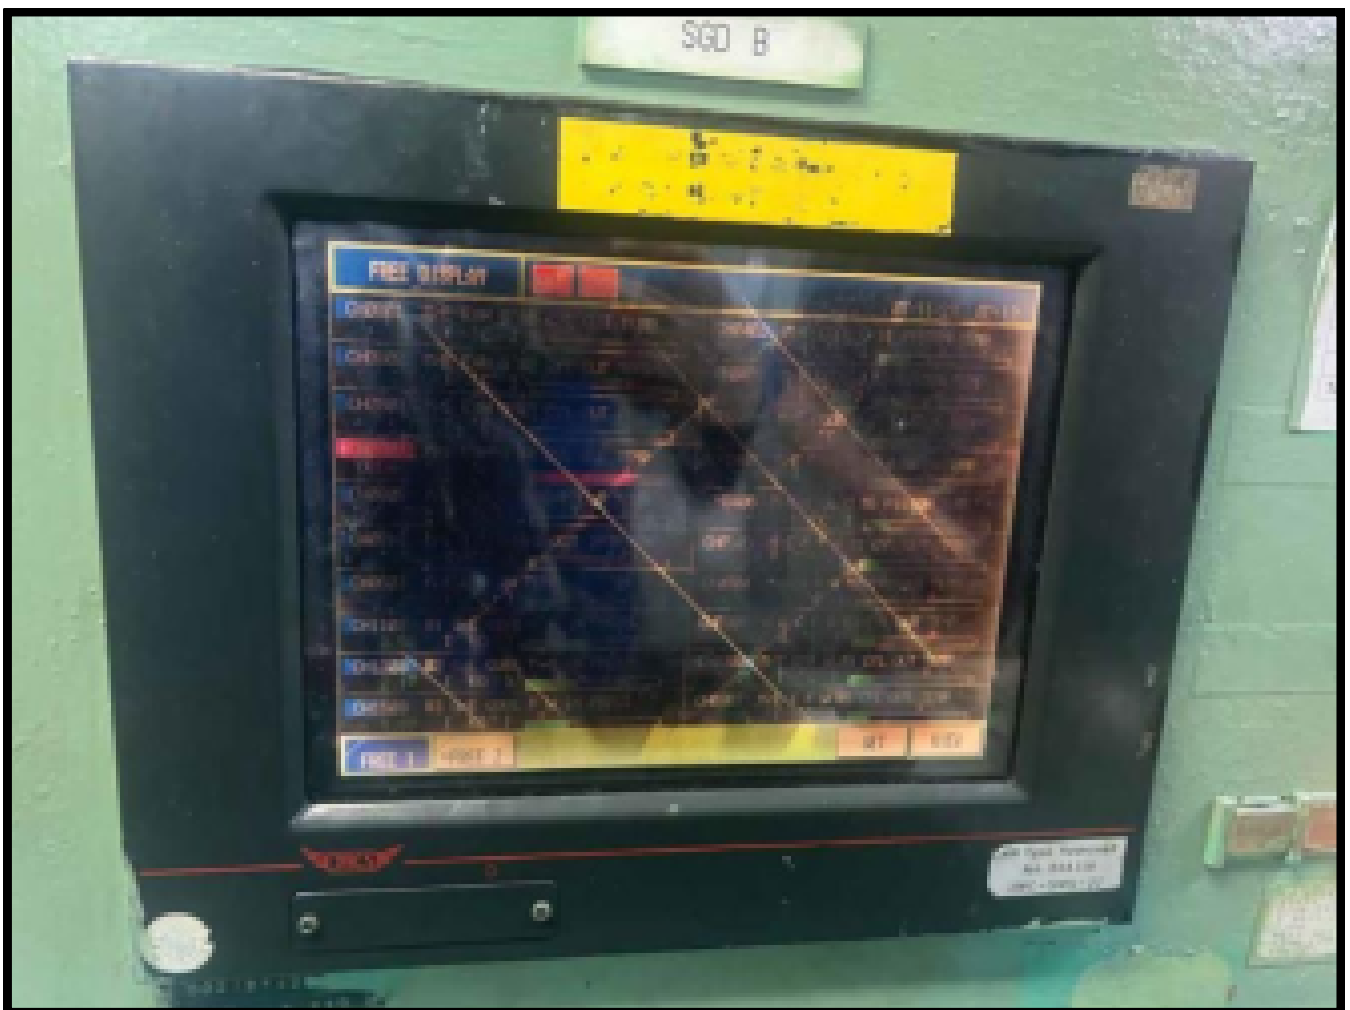
**Malfunction of engine console  
in engine control room**

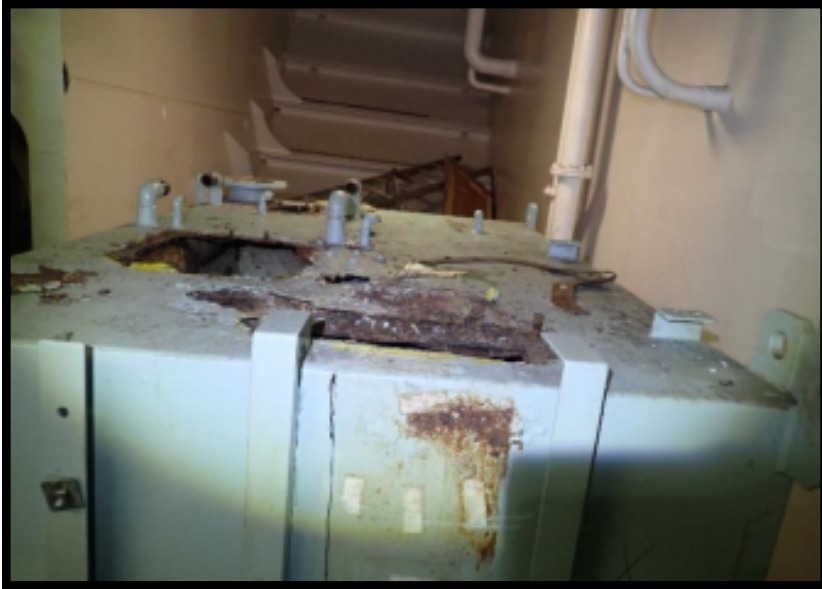
**Corrosion and  
damage of  
sewage  
treatment plant**
