# **FIRE SAFETY**

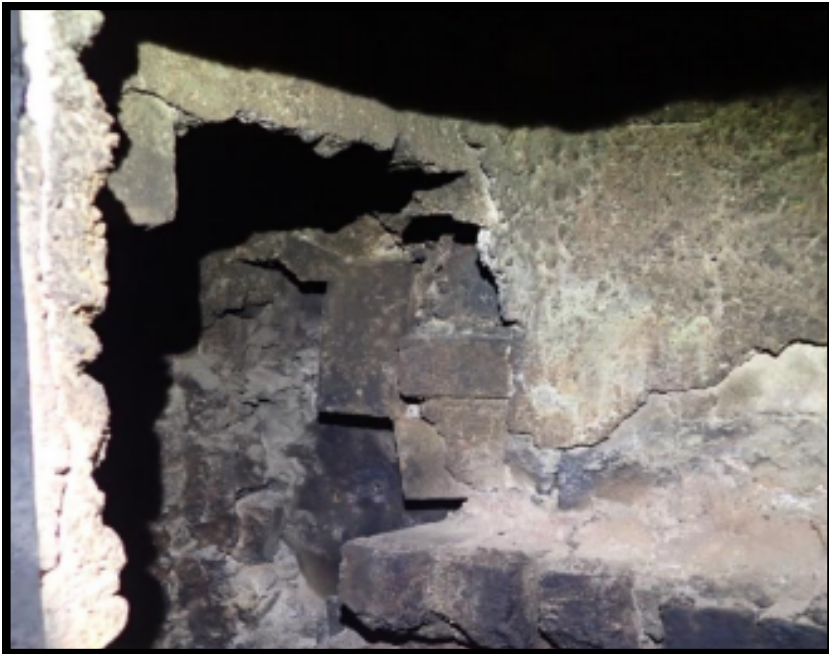
**Damage  
to incinerator  
furnace refractory  
material**

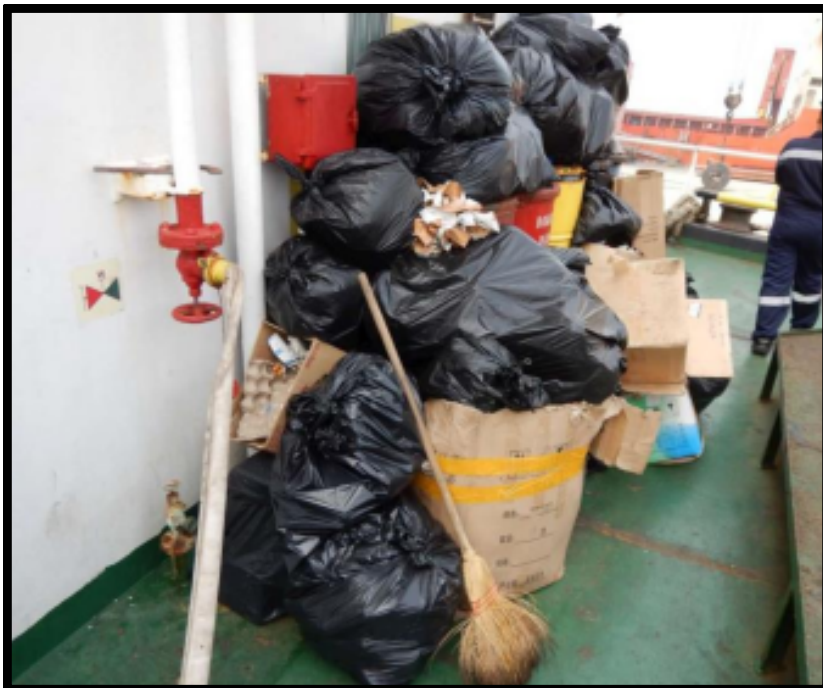
**Inappropriate  
management/  
storage of  
garbage**

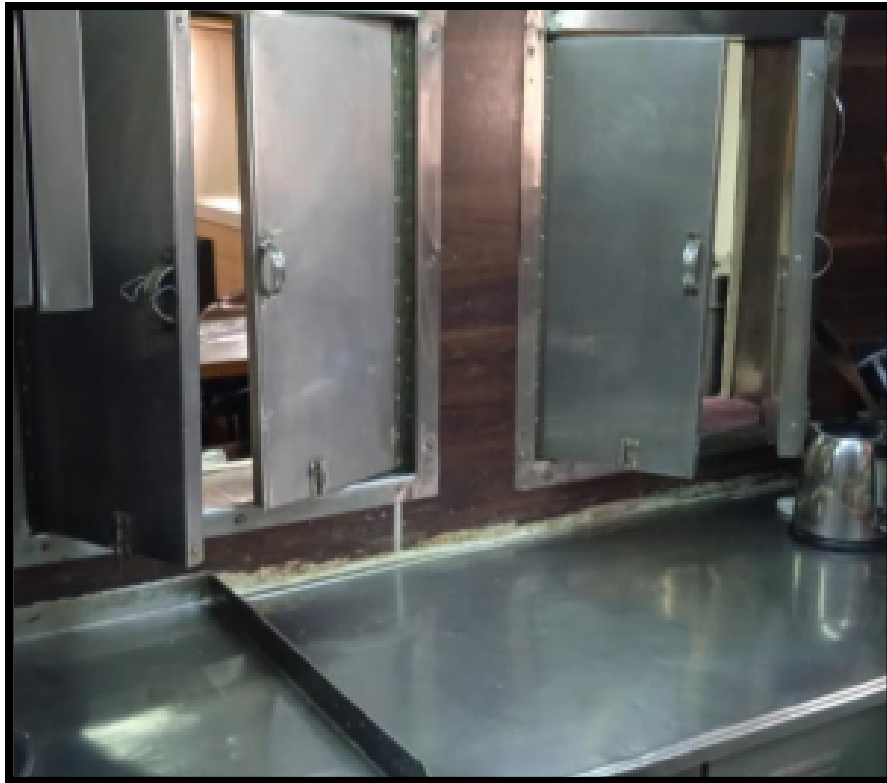
**Modification of fire division without approval**

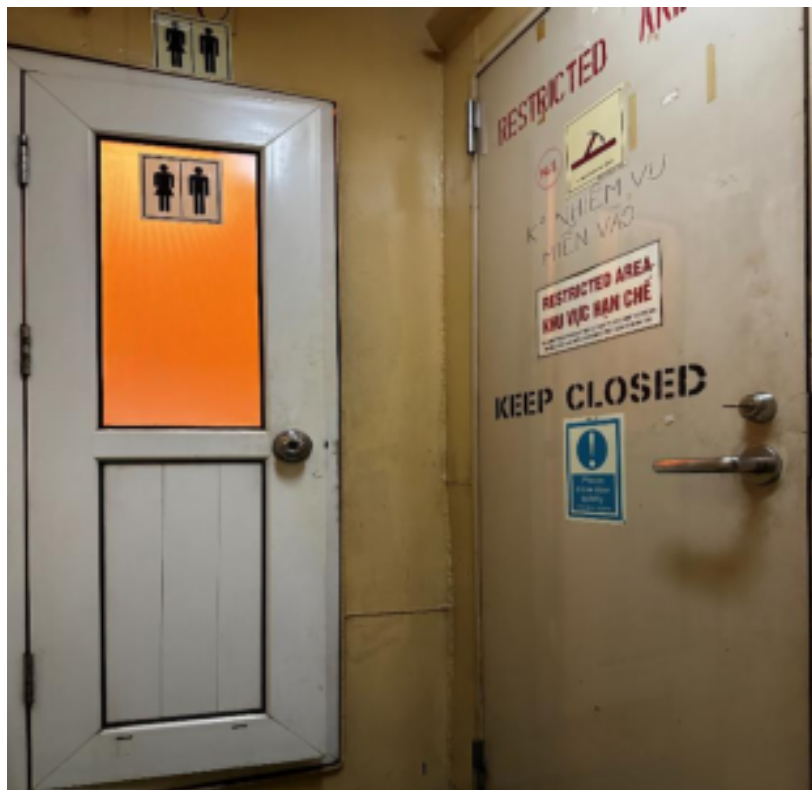
**Modification of accommodation compartment without approval**

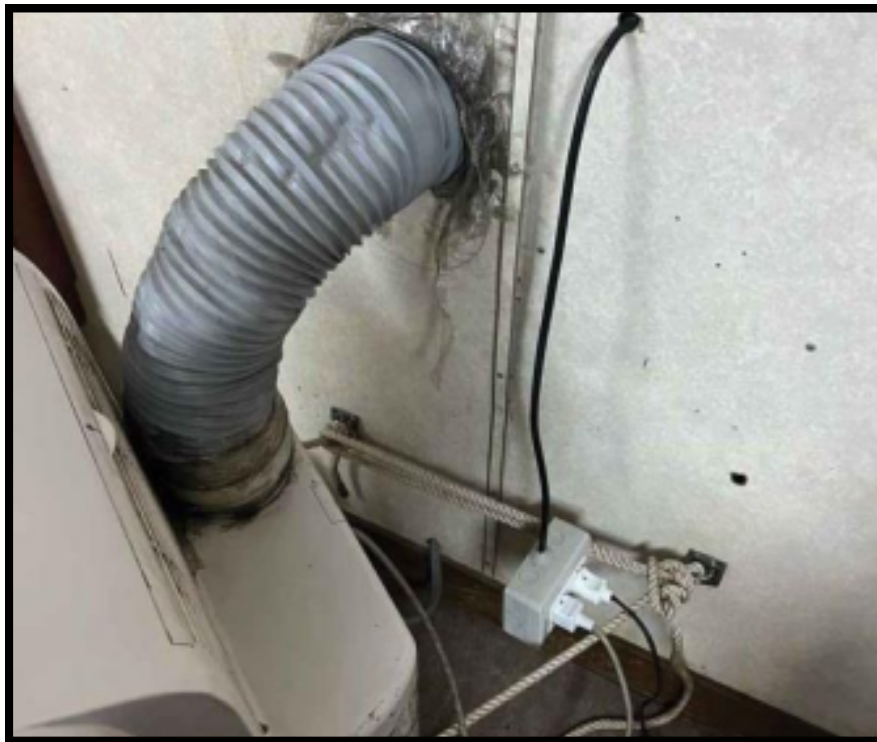
**Modification of electrical equipment and penetration without approval**

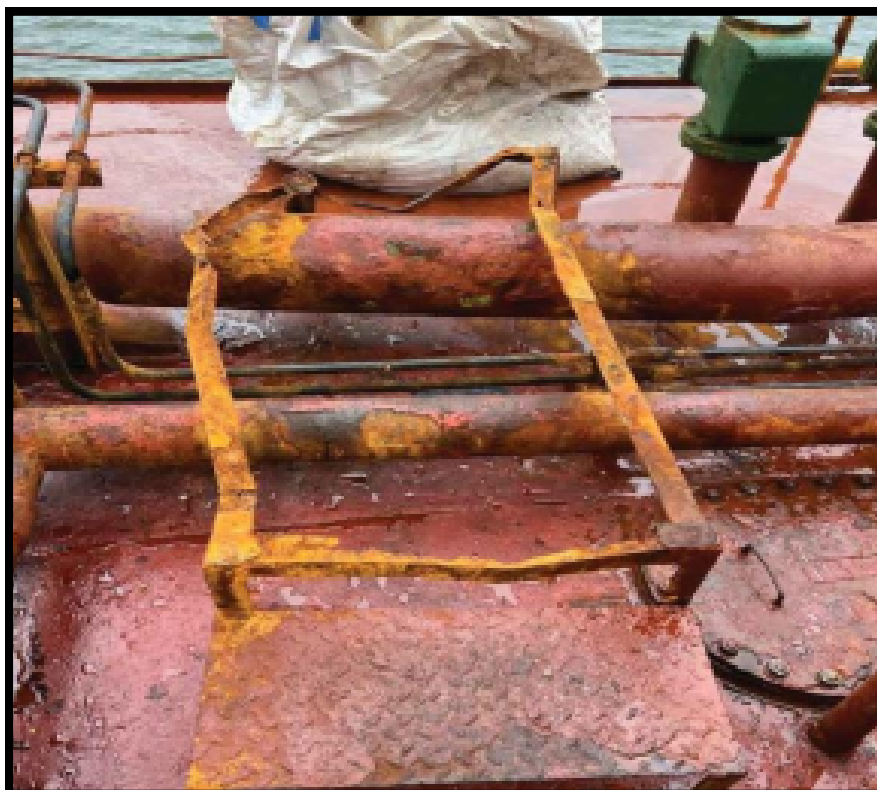
**Damage to upper deck access means**

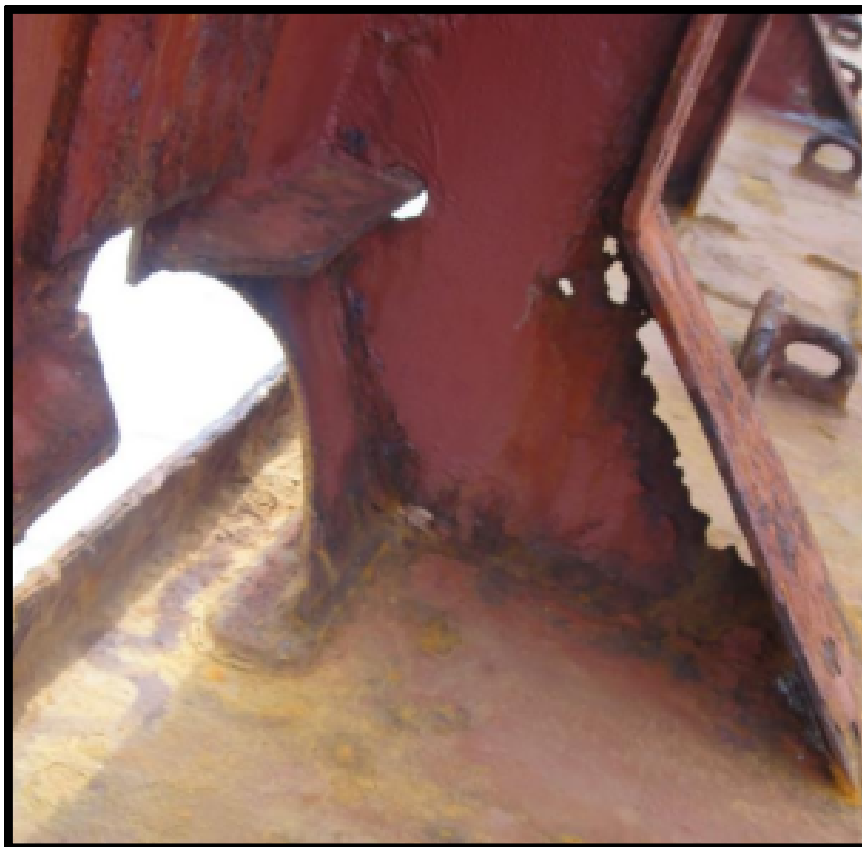
**Corrosion and holes in upper  
deck bulwark stay**

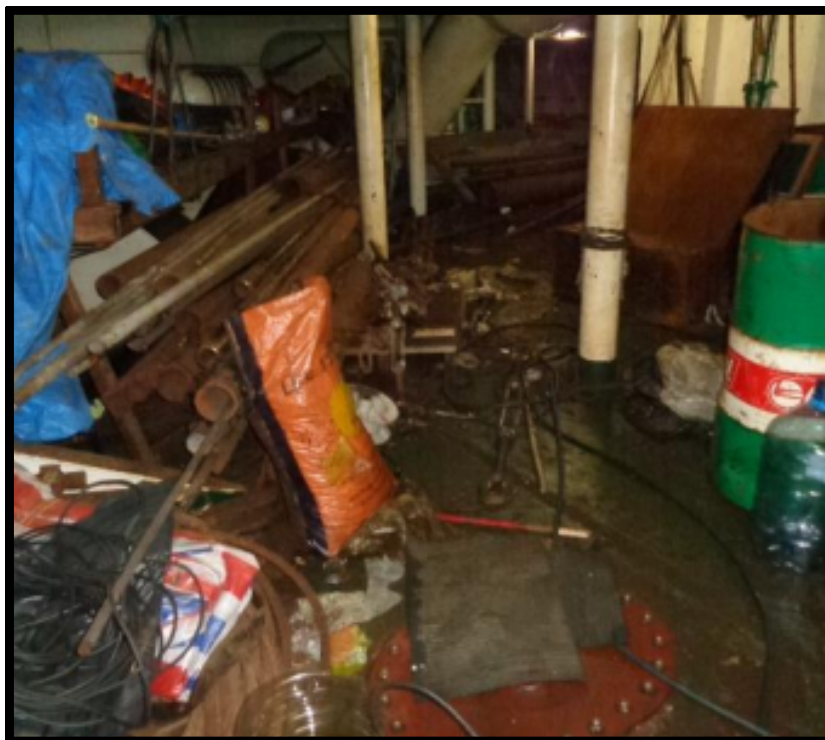
**Disorder in Bos'n Store**
