MARINER'S UPDATE

Voyage : 6

02 JUNE 2026

PSC FOCUS - WK 15

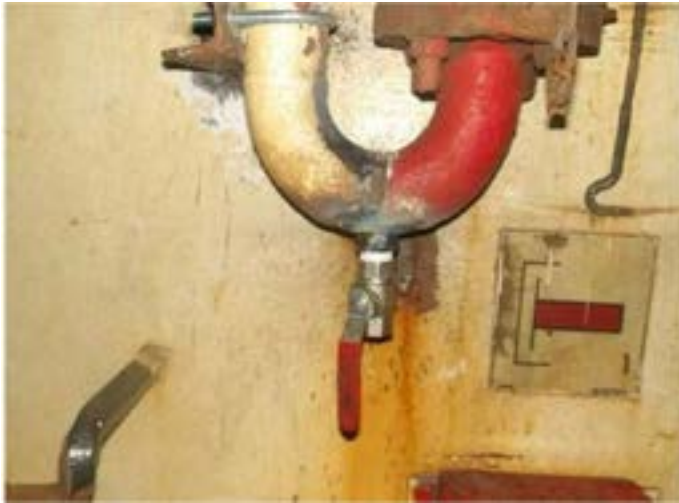
No drainage arrangement is provided at the bottom of the U- shape fire line on both sides of the main deck. Picture posted after rectification of finding.

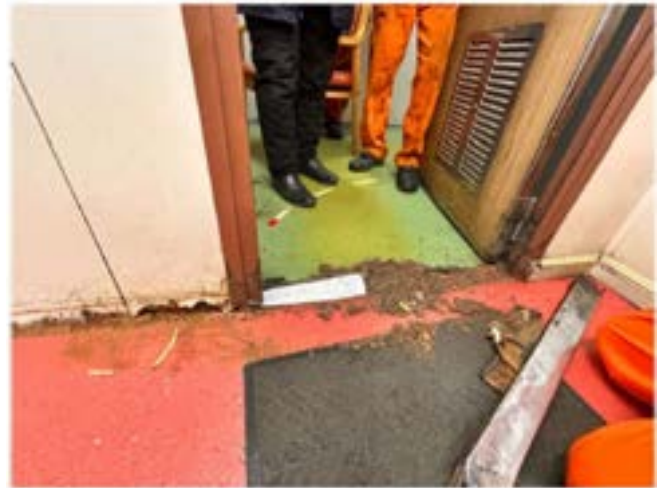
Crew mess room entrance door sill (Class-B fire door) and bulkhead panel wasted. Fire boundary integrity lost.

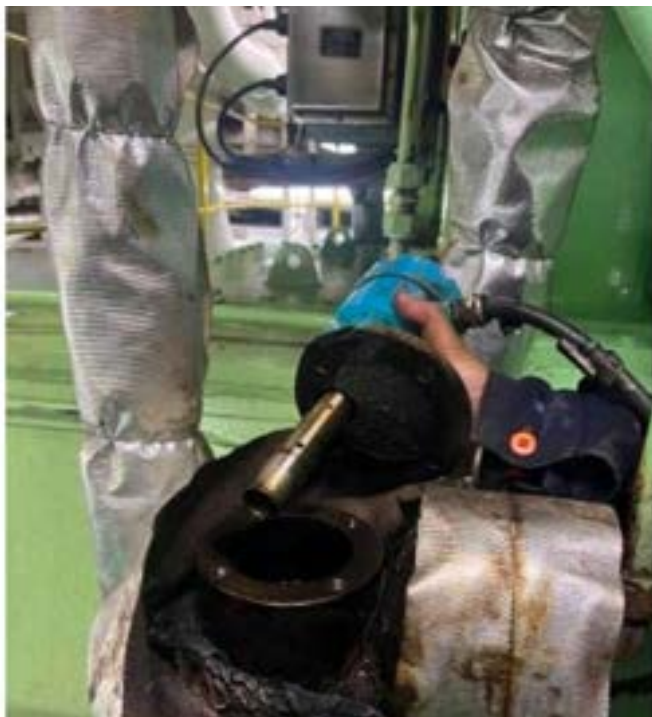
Top cover of Main Engine Fuel Oil leak-off alarm bypassed. Sensor was removed from alarm assembly.

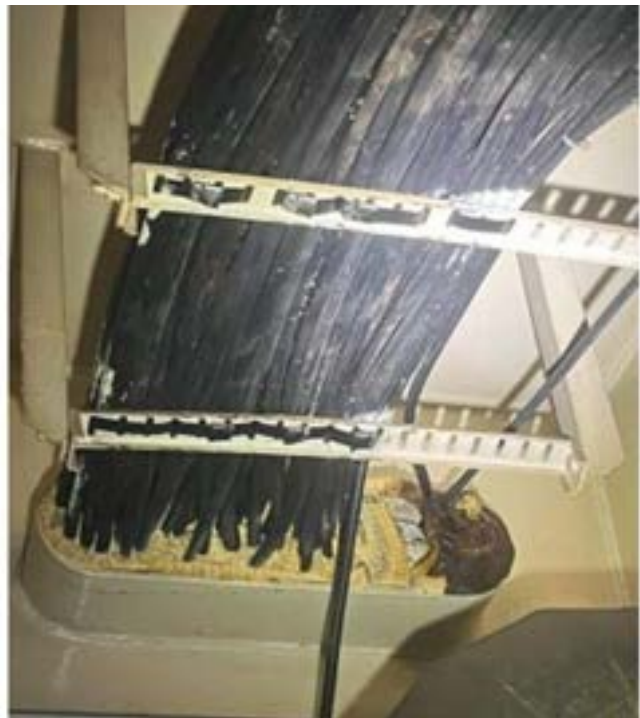
Multi-cable transit in the Engine Room workshop not as required – cable is run outside of the cable transit and improperly sealed.

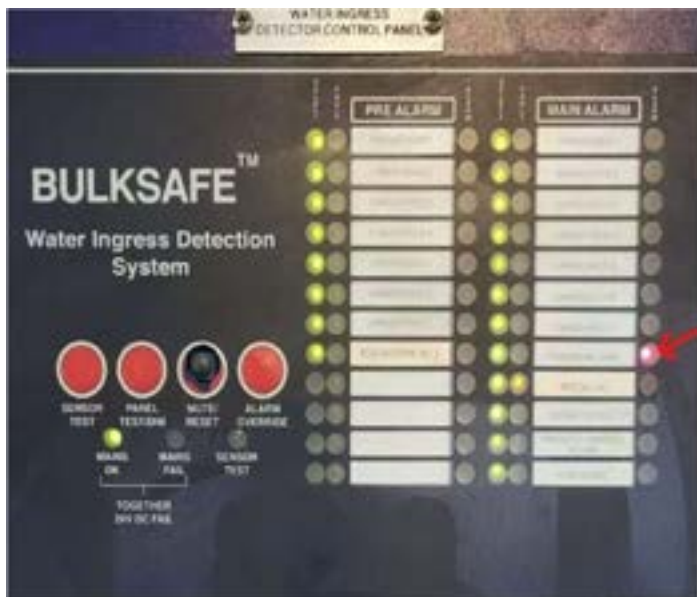
Water ingress alarm system of cargo holds no.4 malfunction.

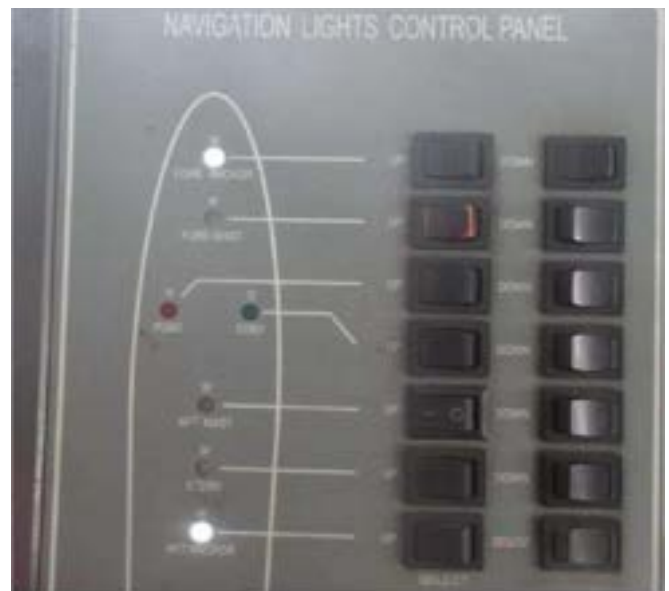
The aft mast light and forward anchor light are out of order.

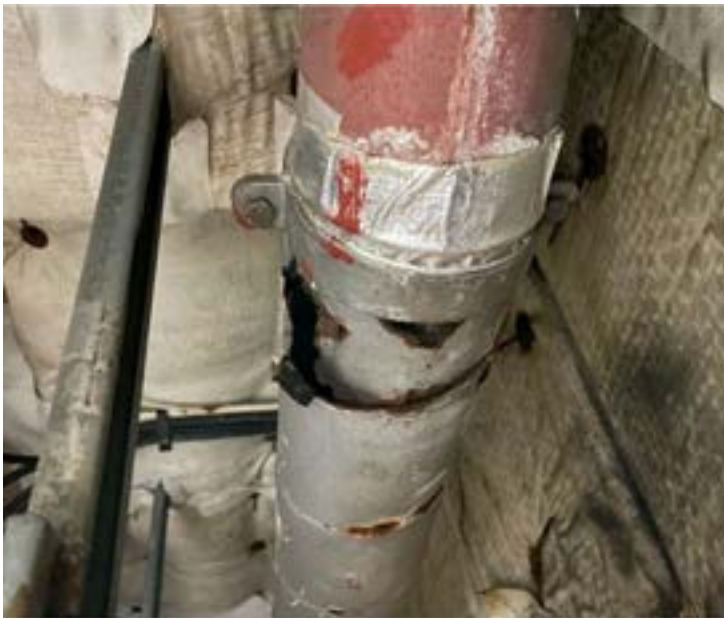
Holed ventilation ducting.

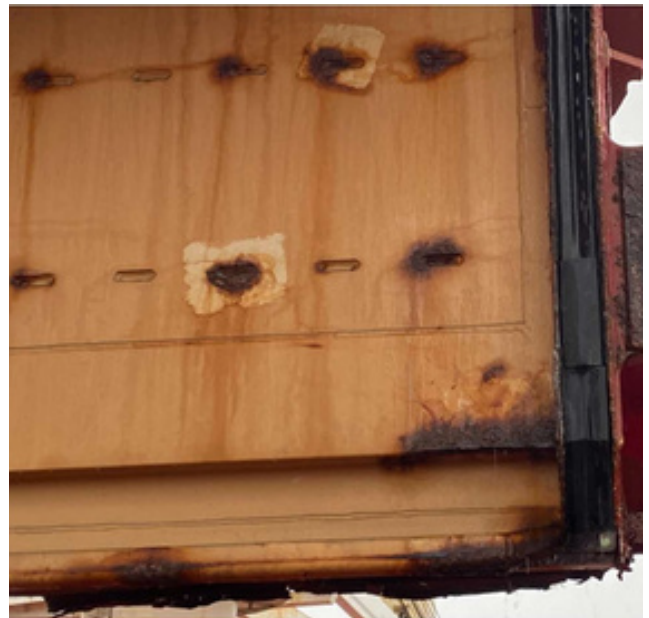
Hatch cover rubber packing found damaged or partially missing.

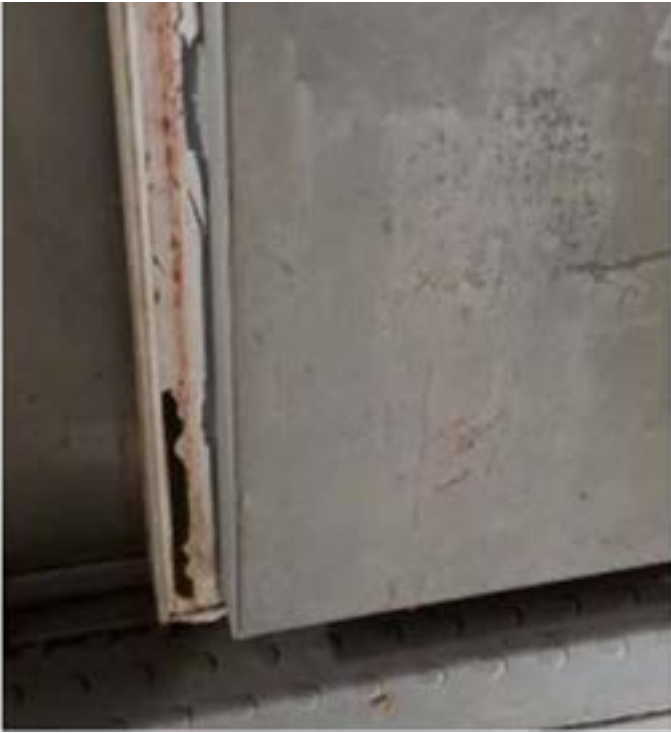
Refrigerator – meat room
doorgasket rubber is deteriorated.

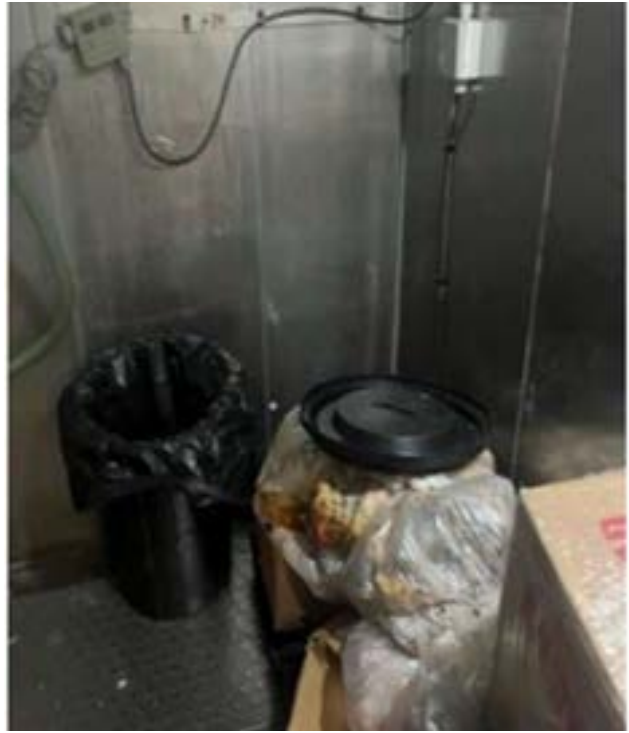
Food waste has been left in
the meat room.

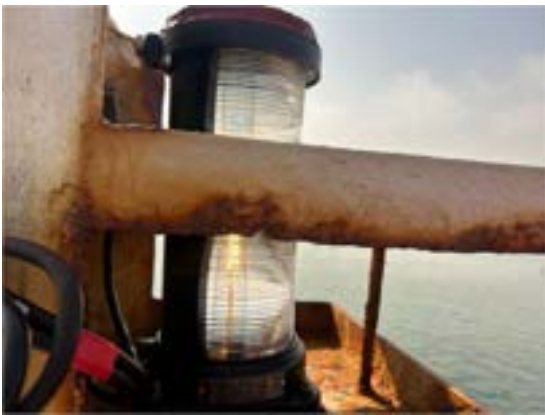
The horizontal light arc of mastlight on top of the forecastle not complying with requirements of COLREG.

Requirements of Masthead light: A white light placed on top of the vessel, shining forward and to both sides (unbroken light over an arc of 225° around the vessel.)

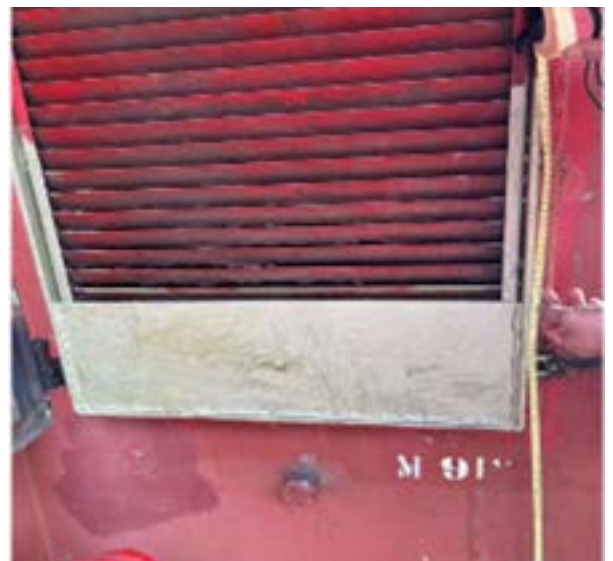
Height of the ventilators at poop deck was modified to 900mm. The original height during PSC inspection was 720mm. Per Load Line Convention/Regulation 19, ventilators in position 1 shall have a coaming height of at least 900mm.

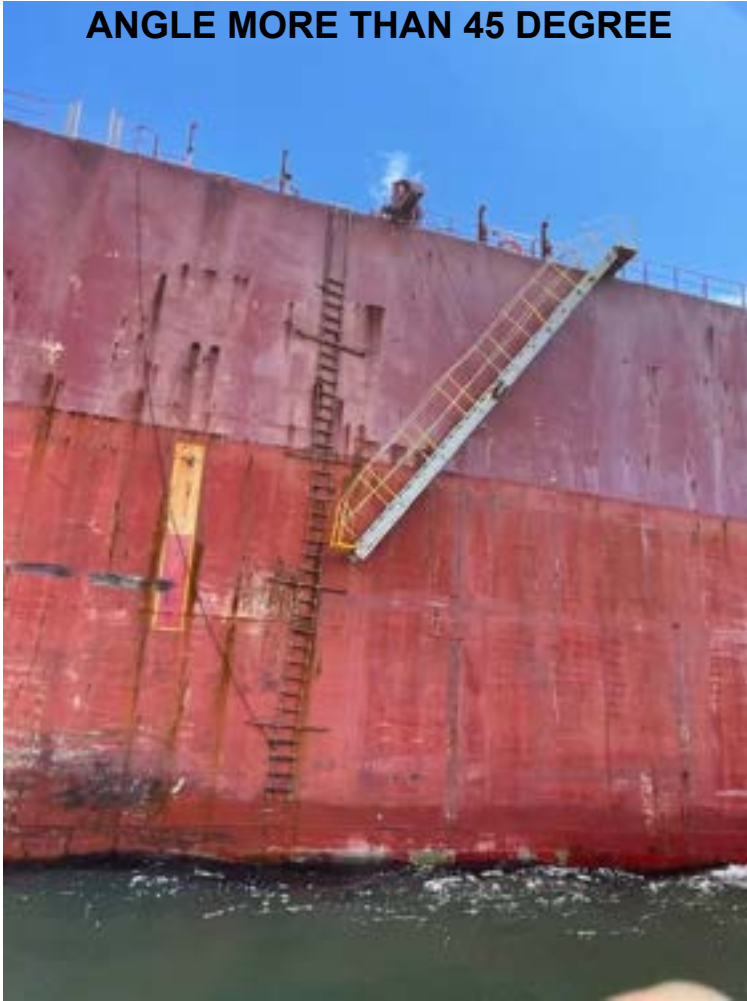
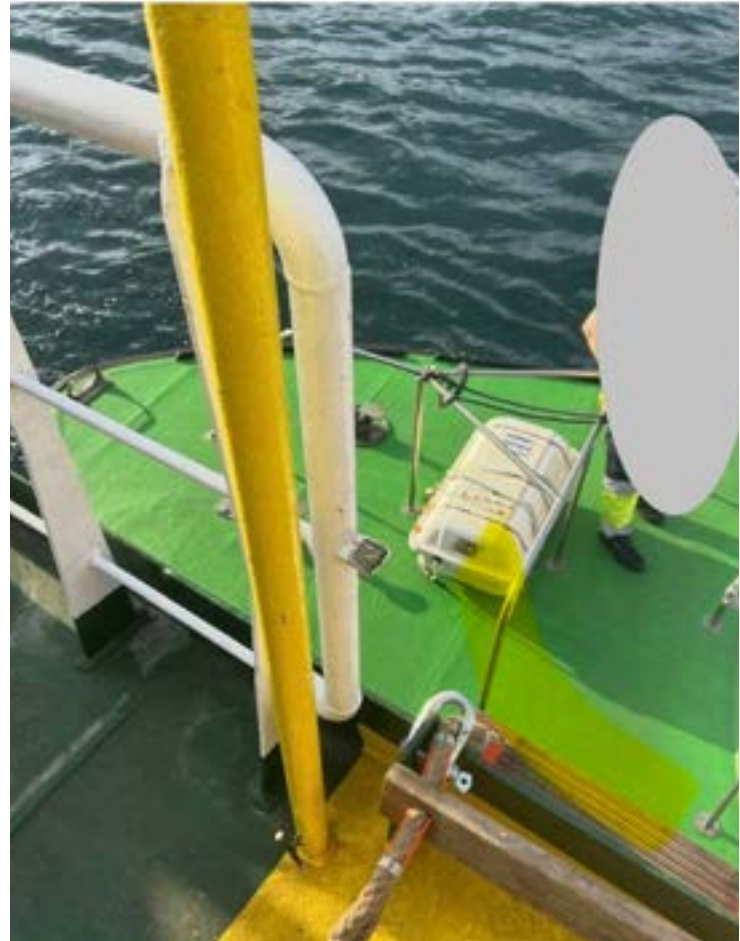
ANGLE MORE THAN 45 DEGREE

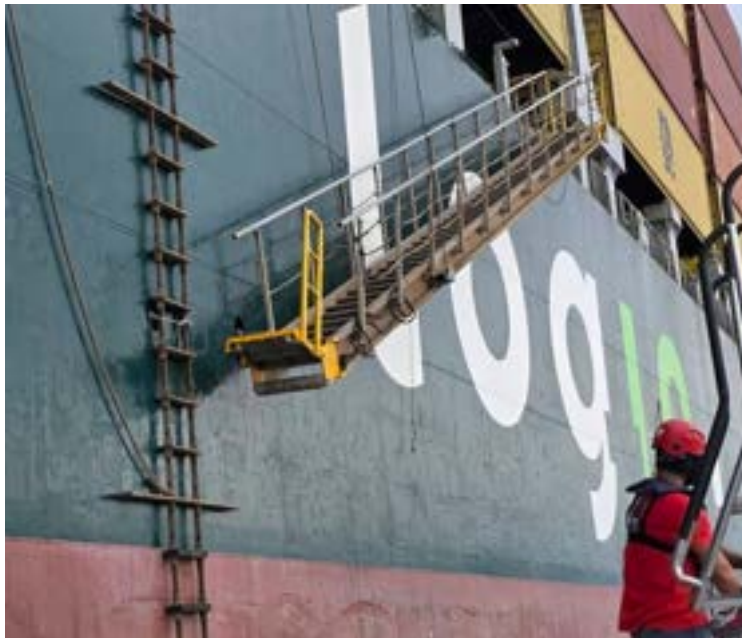
WRONG SECURING, DANGEROUS
