# MARINER'S UPDATE

## PSC FOCUS - WEEK 2

# 35 YEARS OF INCIDENTS

# Competency Gap in Pilot Ladder Knowledge

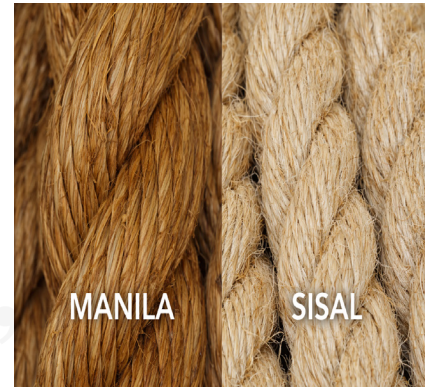
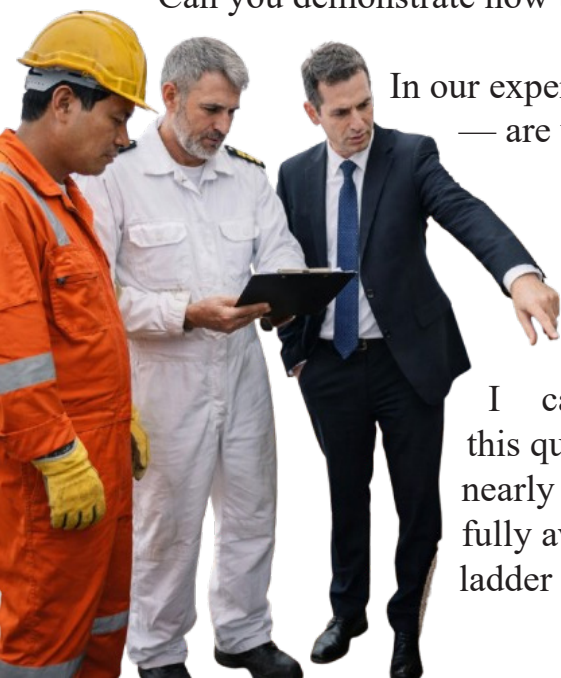
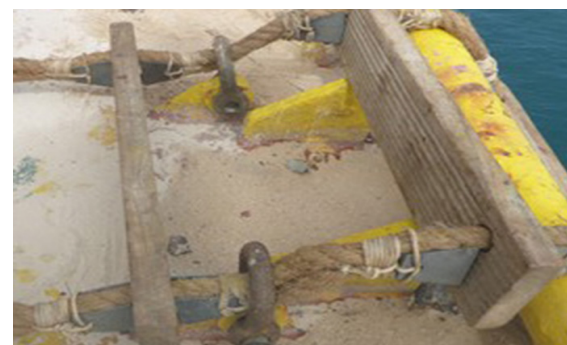
Pilot ladders should normally be secured using proper rope securing methods such as rolling hitch knots on certified strong points, rather than shackles or rigid connections that can create unsafe loading conditions.

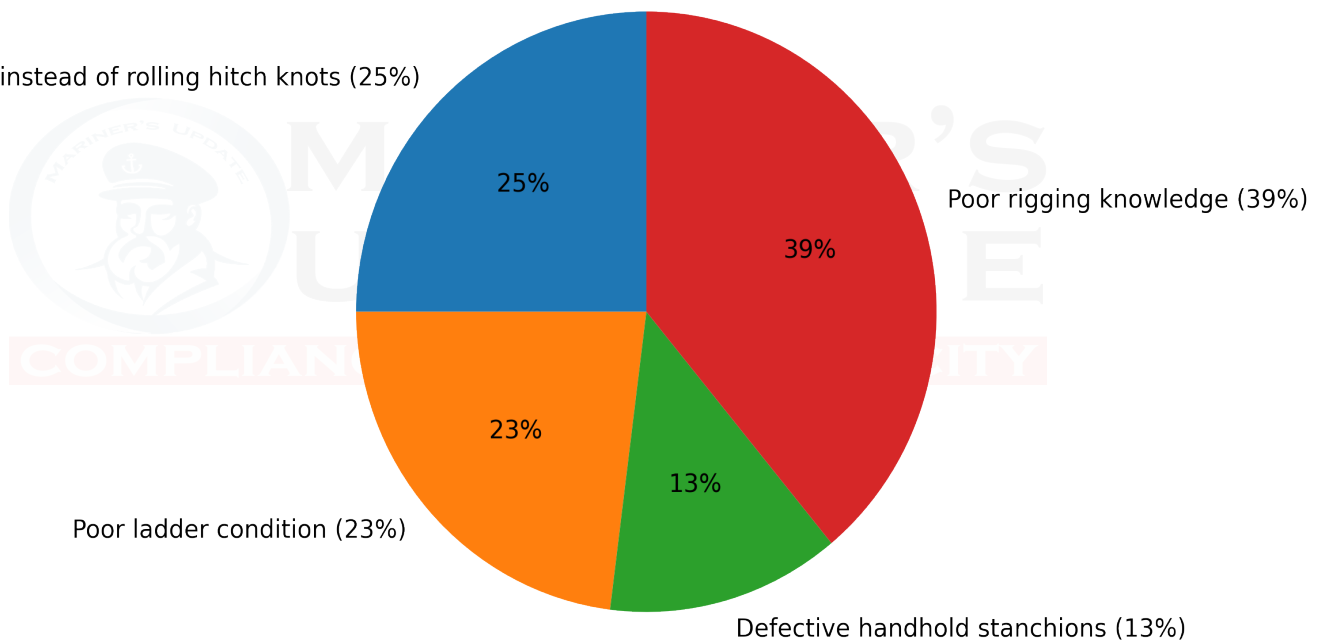
Shackles used instead of rolling hitch knots (25%)

- 25% caused by shackles used instead of rolling hitch knots
- 23% caused by poor ladder condition
- 13% caused by defective handhold stanchions
- 39% caused by poor rigging knowledge
