LOST COMMUNICATION, RESTRICTED ESCAPE, SERIOUS CONSEQUENCES

MISCOMMUNICATION DURING ENCLOSED SPACE INSPECTION INJURES CREW MEMBER

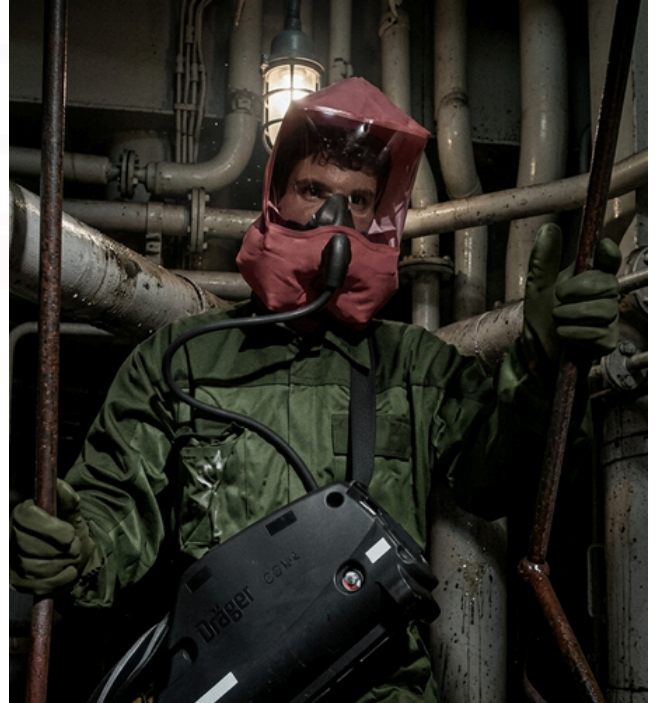
Disoriented, the AB attempted to exit through the starboard hatch, not knowing it had already been secured. While climbing the ladder, he struck his head against the closed hatch cover before the team reopened it for emergency exit.

One of the most serious failures was the closure of an exit hatch while a crew member was still inside the enclosed space.

Exit routes should never be blocked until all personnel have safely exited.
