**THREE INDIAN SEAFARERS KILLED
IN OMAN STRIKE:
A TRAGIC REMINDER OF THE
RISKS FACED AT SEA**

Mariners Update

Focused Inspection Checklist - FOR Panama flag vessel to arrive CHINA MSA

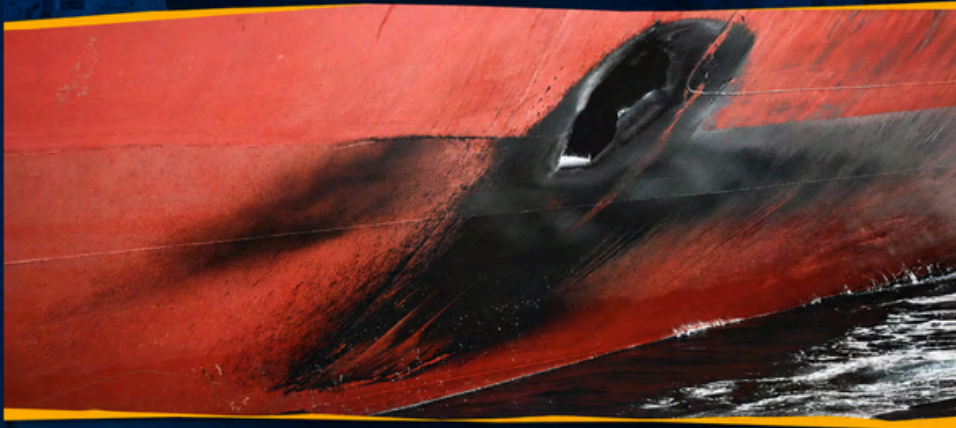
An unexploded missile warhead was discovered onboard the crude oil tanker MT Olympic Life after it was struck by a projectile off the coast of Oman. The Indian Navy's EOD specialists carried out a highly complex and perilous operation to safely recover and dispose of the warhead, preventing a potential catastrophe at sea and reaffirming India's commitment to global maritime safety.

An unexploded missile warhead was discovered aboard MT Olympic Life after penetrating the vessel's hull and becoming lodged inside a fuel tank, creating a serious safety risk.

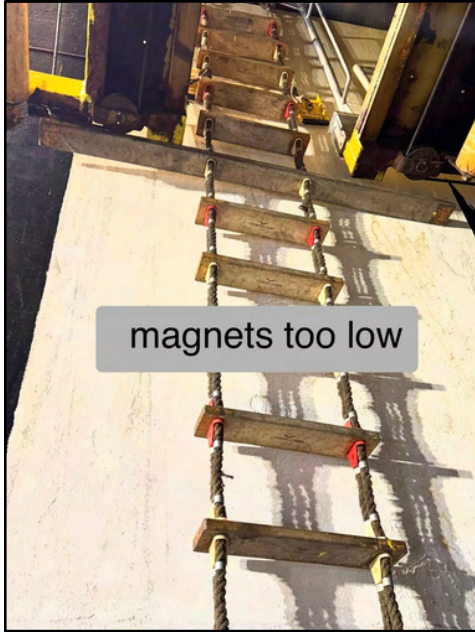
magnets too low

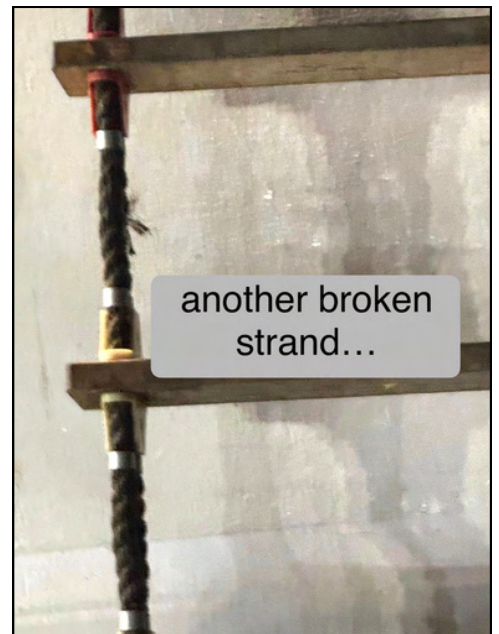
another broken strand...

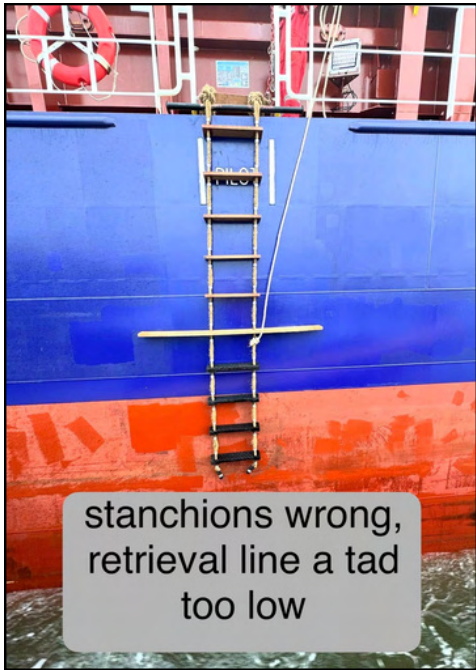
stanchions wrong, retrieval line a tad too low

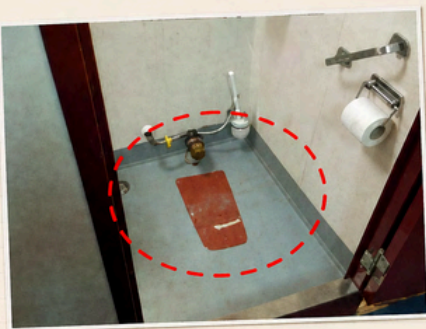
The Missing Toilet

During a recent onboard audit, I opened the door to a crew sanitary space and found something unexpected.

The toilet was missing. Just an empty space remained.

The Maritime Labour Convention requires accommodation and sanitary facilities to be maintained in a decent and habitable condition for seafarers. Crew welfare is not a luxury. It is a statutory requirement.

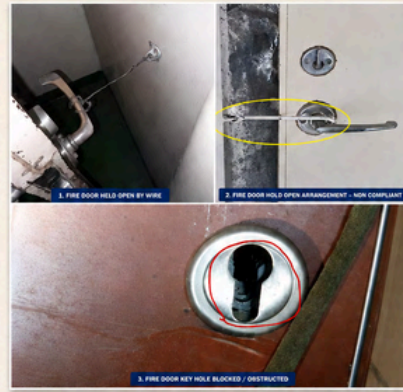
Fire Doors Are Hulk

- Fire doors secured open with wires.
- Improvised hold-back arrangements.
- Damaged locking mechanisms.
- Defective self-closing arrangements.
- Obstructed or damaged door integrity.

Another recurring issue is the everyday seafarer's habit of keeping fire doors open for convenience. Engine room access doors, steering flat entrances, and accommodation fire doors are frequently found lashed open, wedged open, or damaged due to repeated misuse.

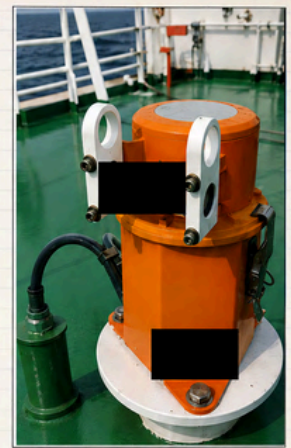
VDR ANALYSING REPORT - monthly by master

- VDR capsule battery expired.
- Multiple bridge microphones were not recording audio.
- Radar image recording interruptions were observed.
- Several recording channels required further verification.

Input	Ok	Not Ok	NA	Remark
All system cable				
Battery in recording unit				EXP.
Battery in float free capsule (Monkey Island)				EXP.
Reserve power source- Emg Power				
Is there any permanent alarm?				
Date and time (UTC)				
Ship Position				
Speed				
Heading				
Communication Audio - VHF 1&2				
Microphone 1	PS WING			
Microphone 2	STB WING			
Microphone 3	STEERING STAND			
Microphone 4	CHART SPACE			
Microphone 5	RADIO SPACE			
Microphone 6	PORT BCC			
Microphone 7	STBD BCC			
Microphone 8				
Radar Main				
Radar Second				
ECDIS				
AIS				
Depth				
Rudder Order and response				
Engine order and Response				
Fire door				
Rolling Motion				
Wind speed and direction
