CRITICAL CO₂ FIREFIGHTING SYSTEM OVERSIGHT DETECTED BEFORE SAILING

CO₂ FIREFIGHTING SYSTEM FOUND INOPERABLE BEFORE SAILING DUE TO MAINTENANCE OVERSIGHT

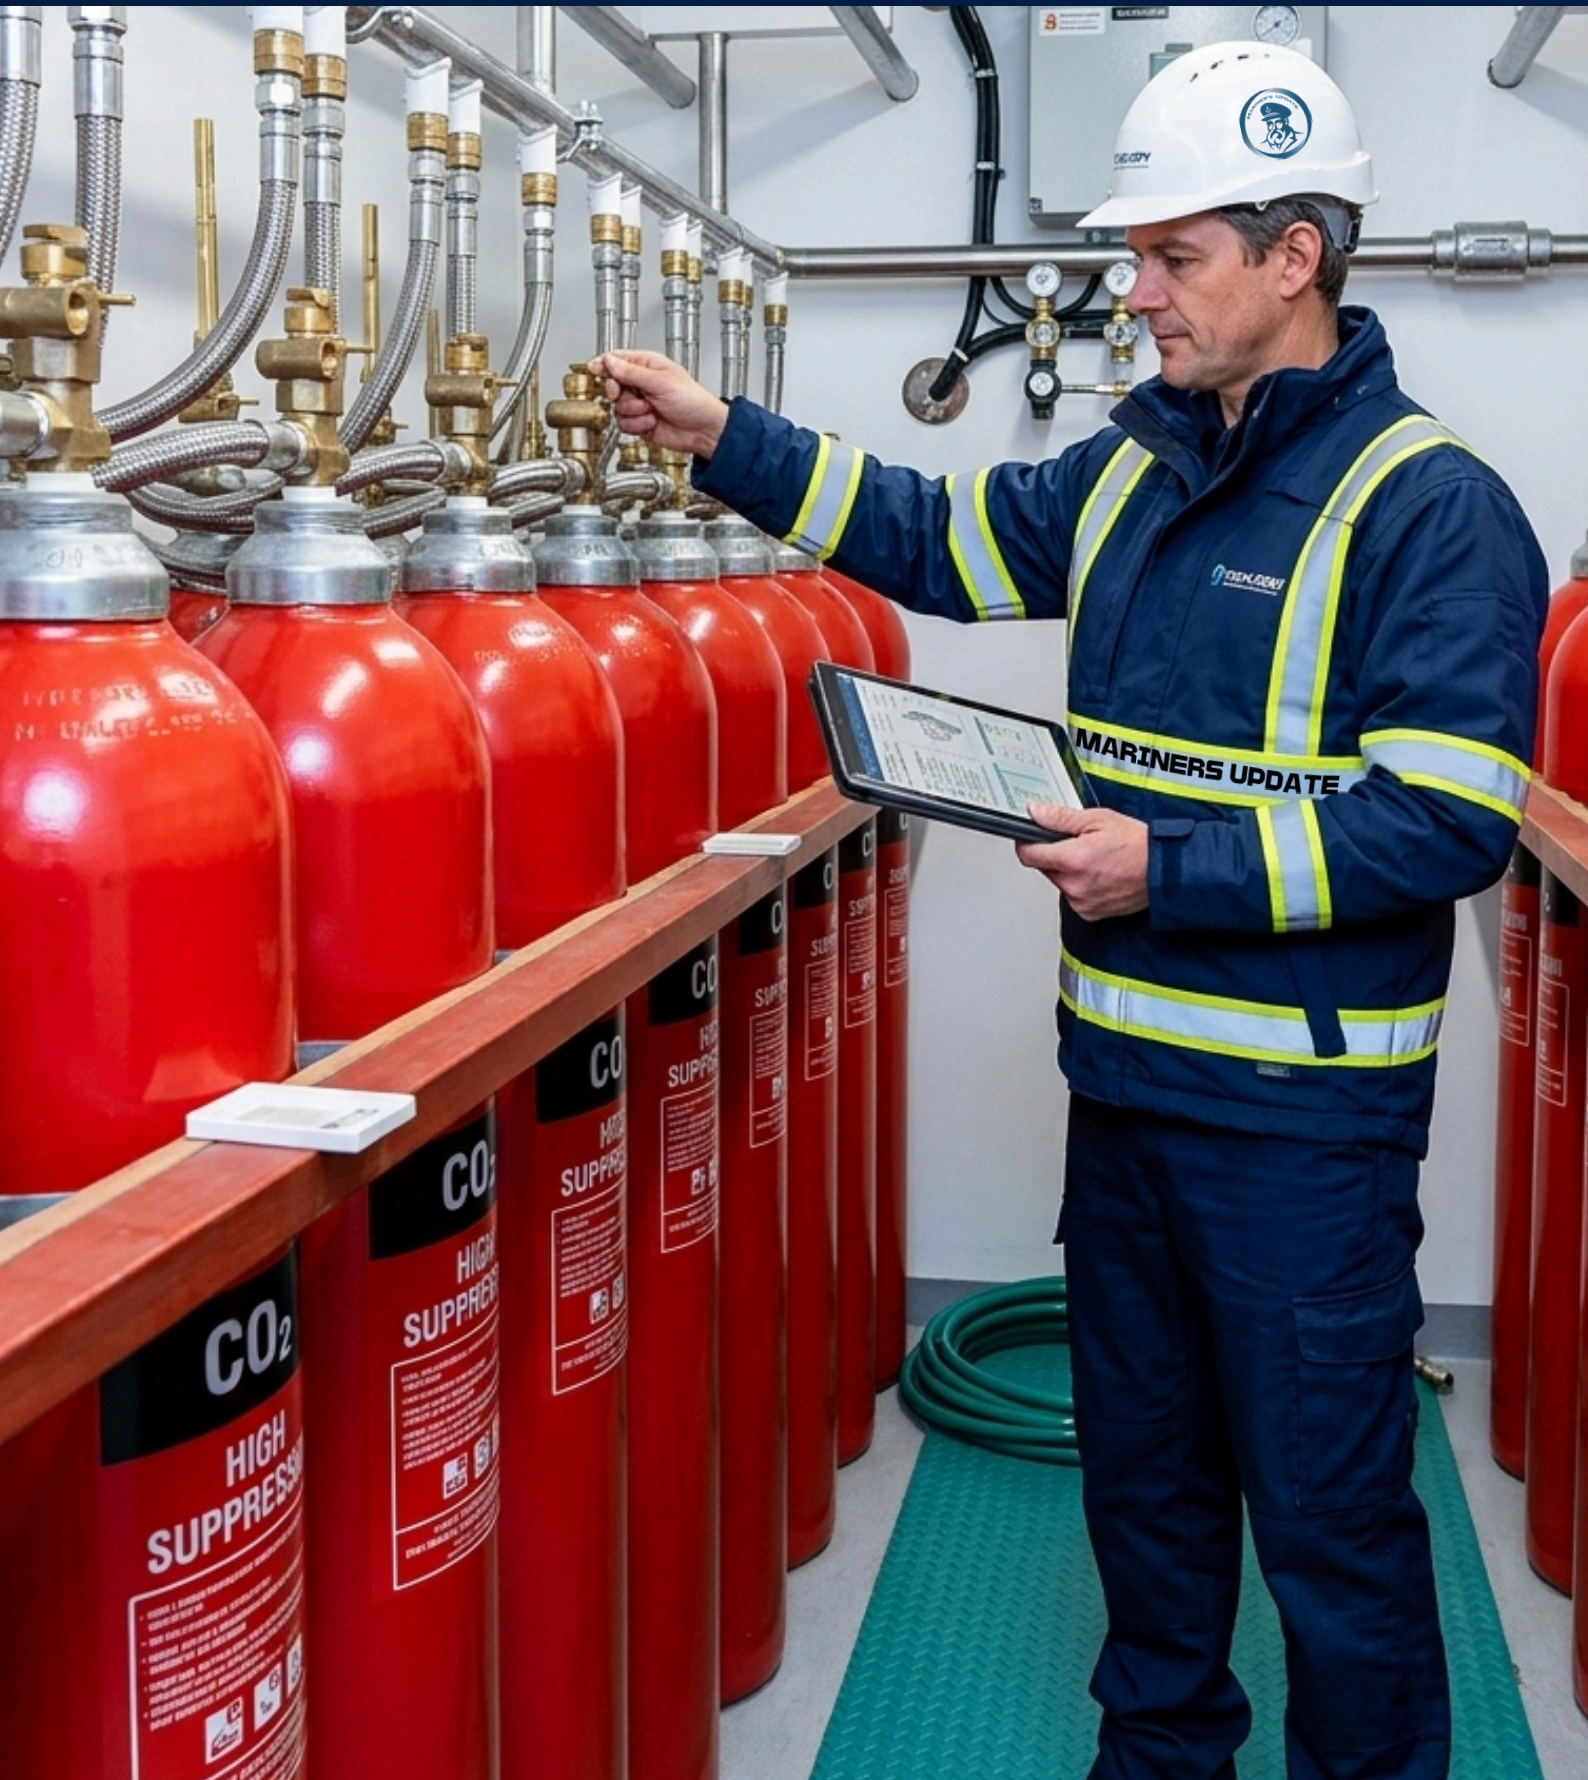
A potentially serious safety failure was identified during a pre-sailing inspection when crew members discovered that safety pins preventing the vessel's fixed CO₂ firefighting system from operating had not been removed after maintenance work.

The pins had been installed by contractors to avoid accidental discharge during servicing. However, once maintenance was completed, the system was returned without restoring it to operational readiness.

During these checks, it was discovered that the locking safety pins inserted into the CO₂ release system remained in place. These pins physically prevented activation of the firefighting system.

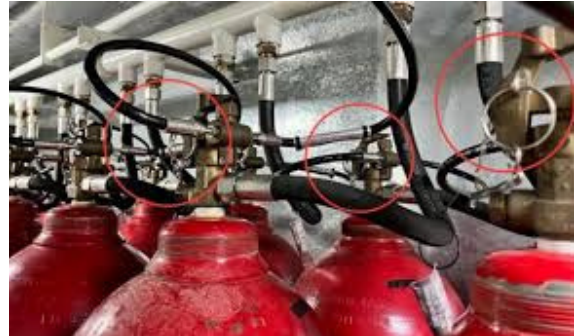
The incident highlighted the importance of proper handover procedures between contractors and ship staff after maintenance work.

- System status
- Operational readiness
- Removal of isolation devices
- Safety restoration

could have prevented the oversight.

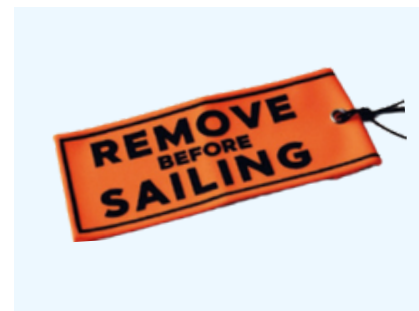
The safety pins were difficult to identify because they visually blended into surrounding equipment. Improved visual indicators such as:

- Bright paint markings
- Warning labels
- “Remove Before Sailing” tags

could significantly reduce the risk of similar incidents.

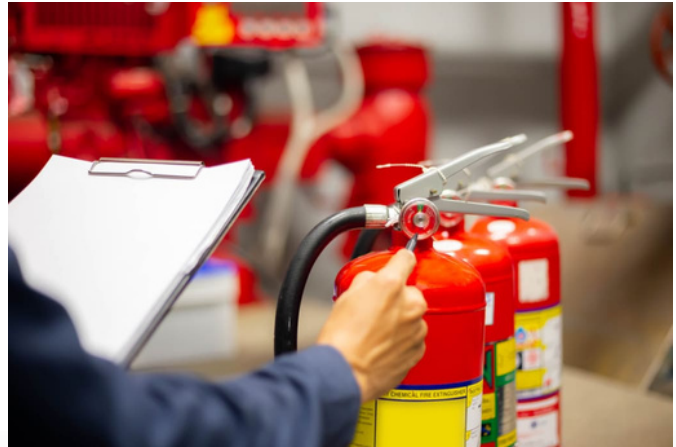
- Never assume maintenance work has been fully completed. Always verify that safety-critical systems are restored to operational condition before departure.

Post-maintenance verification and equipment handover procedures should be strengthened, especially following dry dock periods or contractor involvement.
