PSC FOCUS - WK 13

PSC FOCUS (CARGO SHIPS)

EMERGENCY SOURCE OF ELECTRICAL POWER

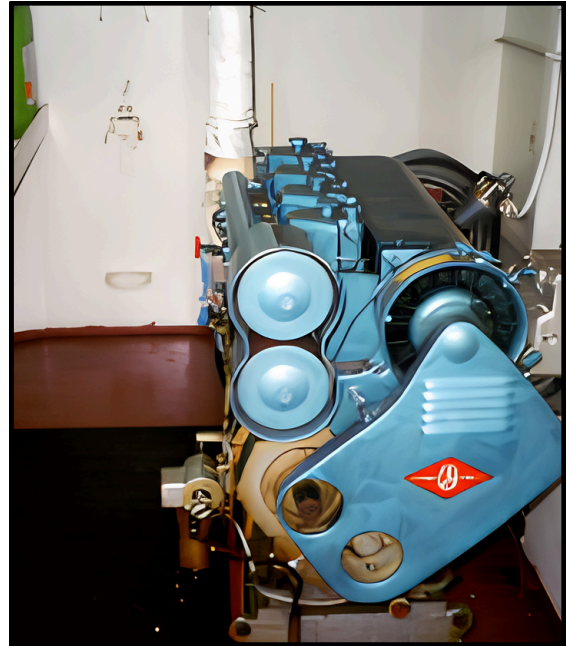
1. EMERGENCY GENERATOR ROOM – PSC OBSERVATIONS

During inspection, the emergency generator room was found not maintained in a satisfactory condition. In several cases, access doors were defective, spaces were used for storage of spare parts or equipment, and housekeeping standards were poor with traces of oil, fuel, or water observed on deck plating.

Emergency operating instructions were either missing or not clearly displayed. Ventilation arrangements, lighting, and communication systems were not fully operational or adequately maintained. Fire extinguishing arrangements were also found overdue for servicing or not readily available for immediate use.

- Emergency generator room used for storage purposes
- Oil/fuel leakage inside compartment
- Poor cleanliness and housekeeping
- Defective lighting or ventilation
- Missing emergency operating instructions
- Communication equipment not operational
- Fire extinguishers not properly maintained

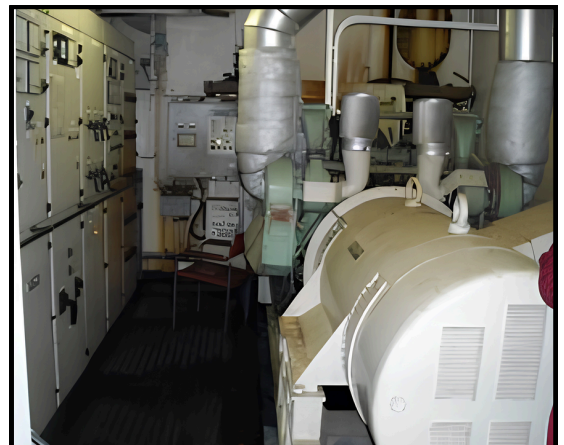
2. FUEL SYSTEM & FUEL LINE DEFICIENCIES

The emergency generator fuel system was inspected and deficiencies were identified relating to inadequate fuel quantity, leaking pipelines, temporary clamps fitted on fuel lines, and defective quick-closing arrangements.

Sight glasses used for fuel level indication were found without proper self-closing devices, while some fuel tank manholes showed evidence of leakage. Flexible hoses were also observed in deteriorated condition or unsuitable for marine service.

- Insufficient fuel quantity for emergency operation
- Leakage from fuel pipes or fittings
- Temporary repairs/clamps fitted on pipelines
- Defective quick-closing valves
- Fuel tank leakage around manhole covers
- Damaged or non-approved flexible hoses

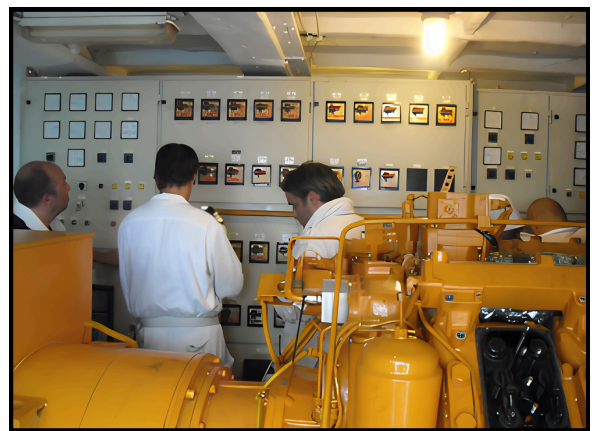
3. EMERGENCY SWITCHBOARD DEFICIENCIES

PSC inspections identified emergency switchboards in unsatisfactory condition due to poor maintenance, missing labels, defective instrumentation, and inadequate insulation arrangements.

Switchboard lighting arrangements were occasionally inoperative, and insulating mats were missing in front of live electrical panels, presenting a potential safety hazard during emergency operation.

- Poorly maintained emergency switchboard
- Missing circuit identification labels
- Defective gauges or switches
- Missing insulating mat
- Inoperative switchboard lighting
- Signs of overheating or poor maintenance

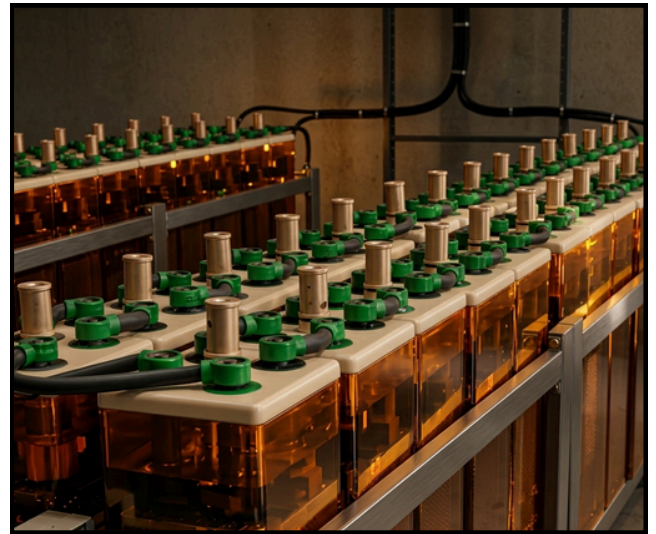
5. BATTERY ROOM DEFICIENCIES

Battery compartments were inspected for ventilation, cleanliness, securing arrangements, and electrical safety. Several deficiencies were noted where batteries were improperly secured, ventilation was inadequate, warning signs were missing, or electrical fittings were not explosion-proof.

Loose battery cables and poorly maintained charging systems were also identified during inspection.

- Inadequate ventilation inside battery room
- Batteries not properly secured
- Missing warning signs
- Loose or damaged battery cables
- Defective charging equipment
- Non-explosion-proof electrical fittings
